# Inspection Report

**Avelar Home Inspection Inc.**  
We see what you can't.

January 29, 2026

1234 Sample Road, Ottawa,  
Ontario, K1K 1K1

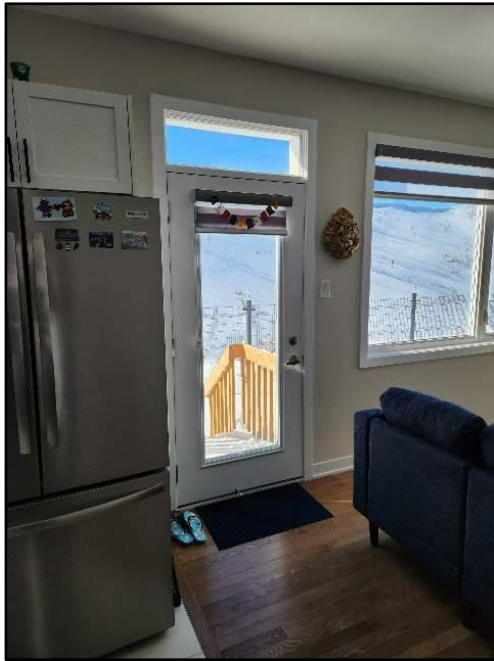
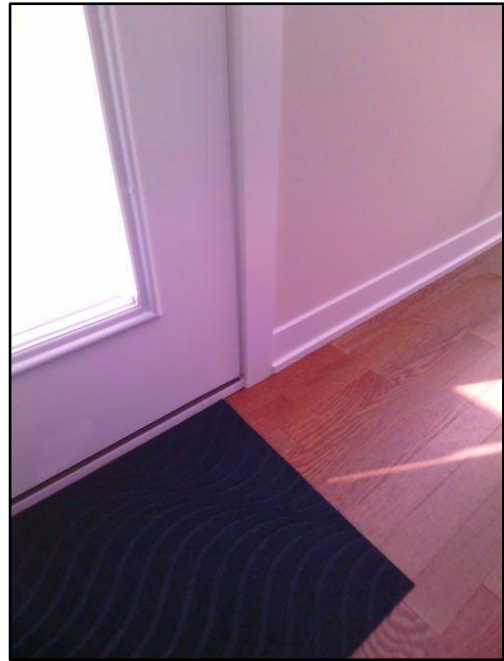
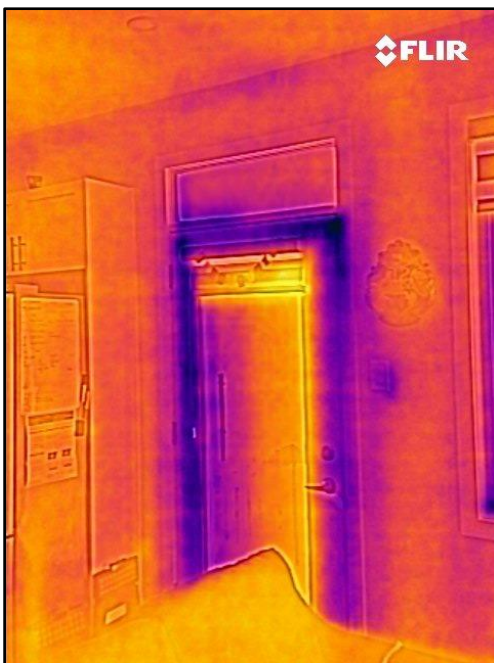
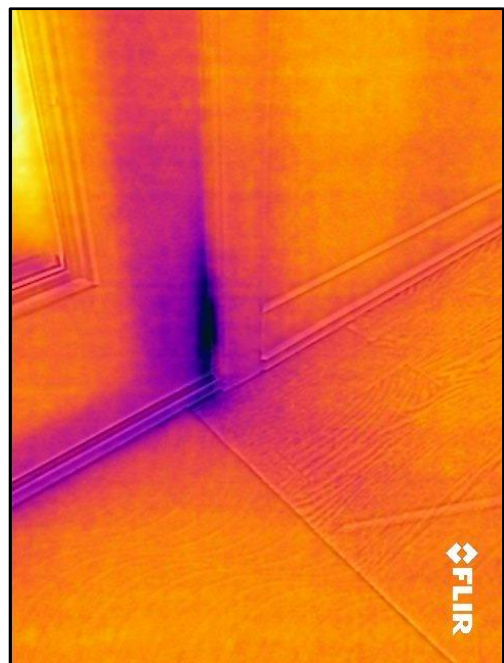
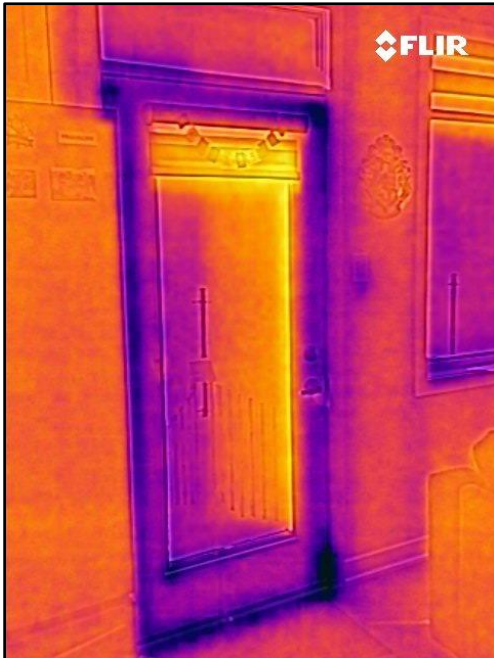
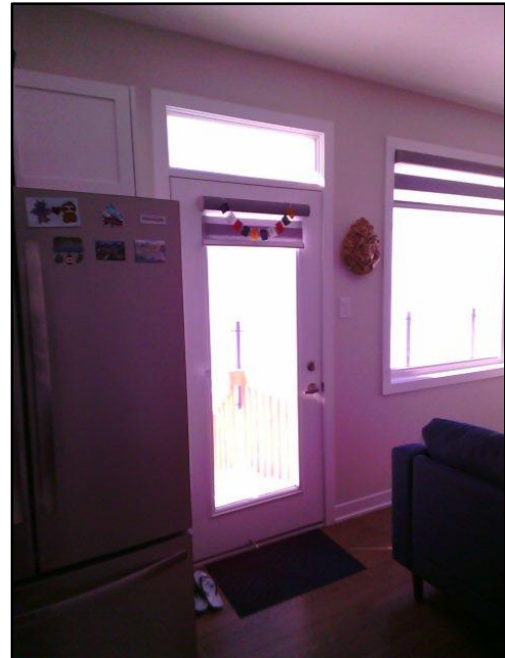
During the inspection, the inspector observed signs of air leakage affecting one or more exterior door assemblies.

- Drafts or cold spots, especially near the door edges or sill
- Visible gaps, between the door and frame or threshold
- Loose or deteriorated weatherstripping, allowing air infiltration
- Misaligned door panels, from seasonal expansion or hinge wear
- Condensation or frost, near leak points during cold weather
- Increased heating or cooling costs, due to reduced thermal performance
- Interior finish damage, such as peeling paint or warped flooring near leak zones

3. Air leaks

The inspector recommends evaluation by a qualified door contractor or energy efficiency specialist to determine whether weatherstripping replacement, threshold adjustment, frame repair, or air sealing upgrades are warranted to restore proper safety, performance, and appearance.

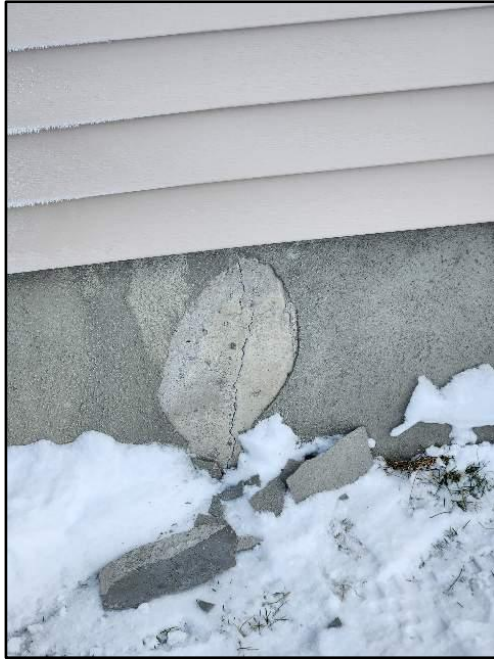
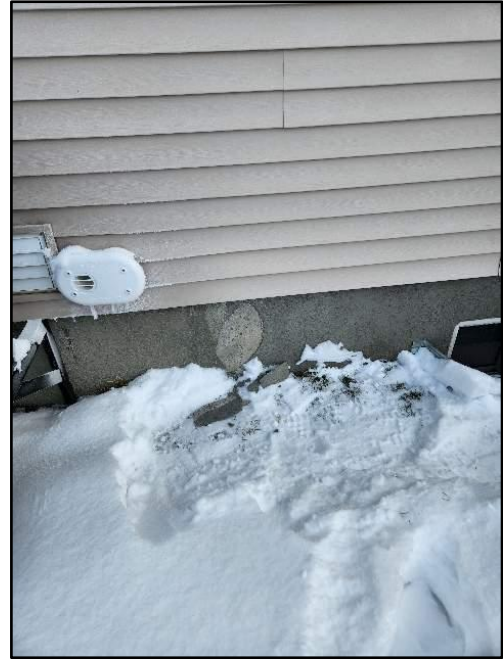
During the inspection, the inspector observed typical minor cracks in one or more foundation components, consistent with normal concrete curing, seasonal movement, or age-related settling.

- Hairline vertical or diagonal cracks less than 1/8 inch wide
- Uniform shrinkage cracks near corners or control joints
- No signs of displacement, water intrusion, or structural stress

14. Typical minor cracks

The inspector recommends routine monitoring and evaluation by a qualified foundation specialist if cracks widen, multiply, or show signs of water penetration or structural movement.

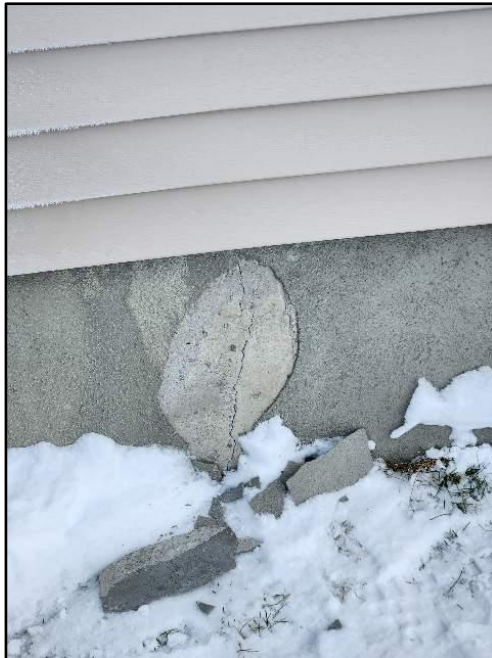
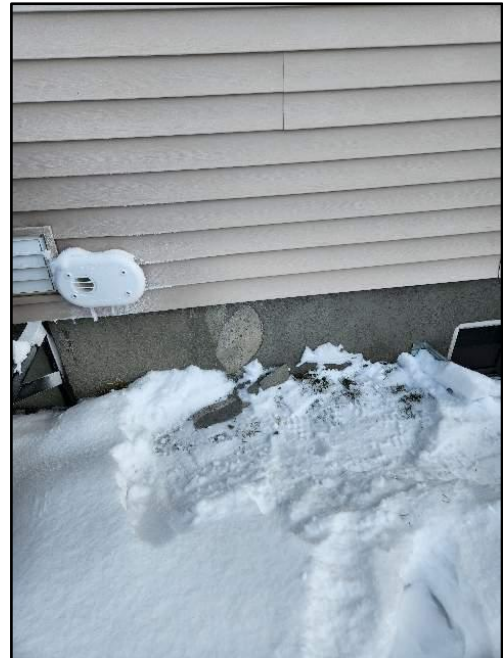
- **Parging damaged or missing**

16. Parging damaged or missing

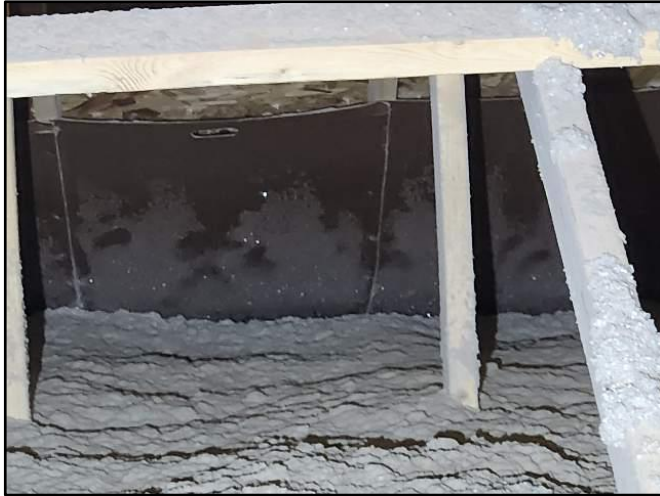
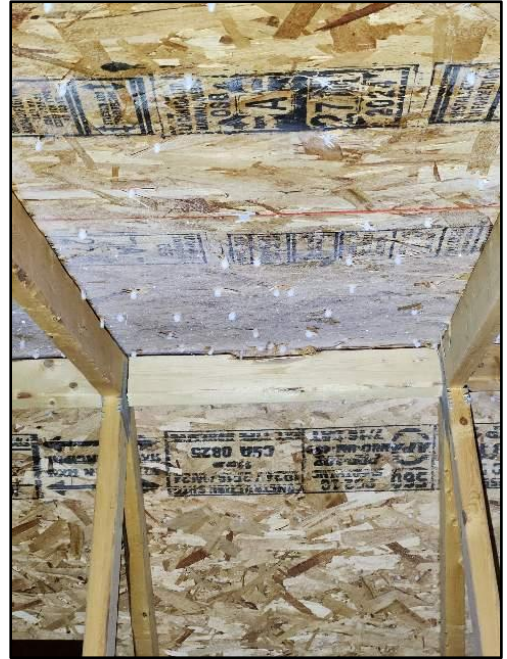
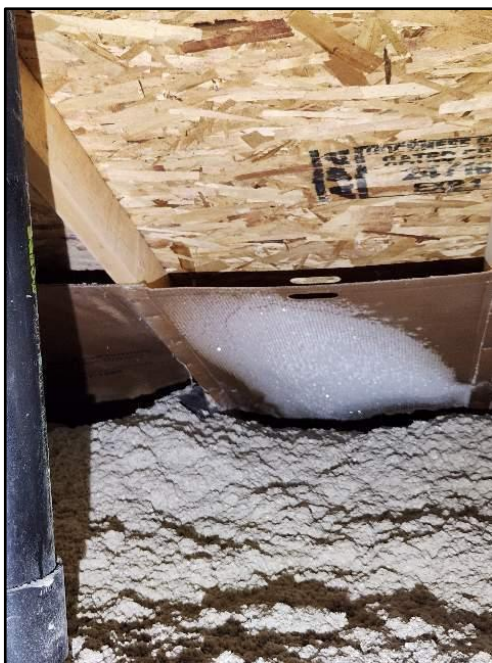
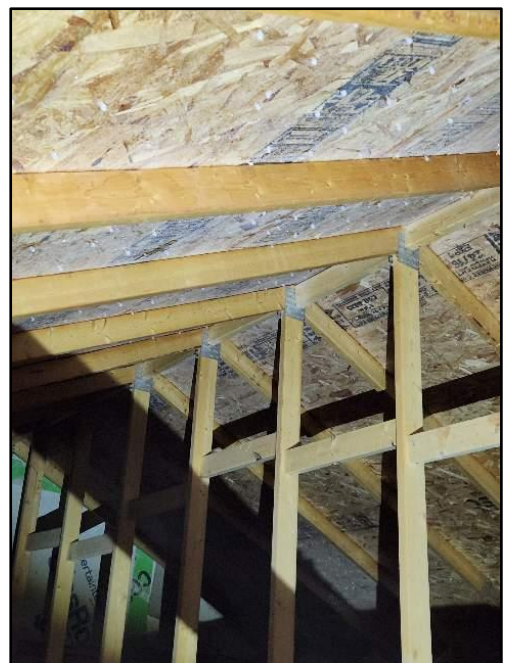
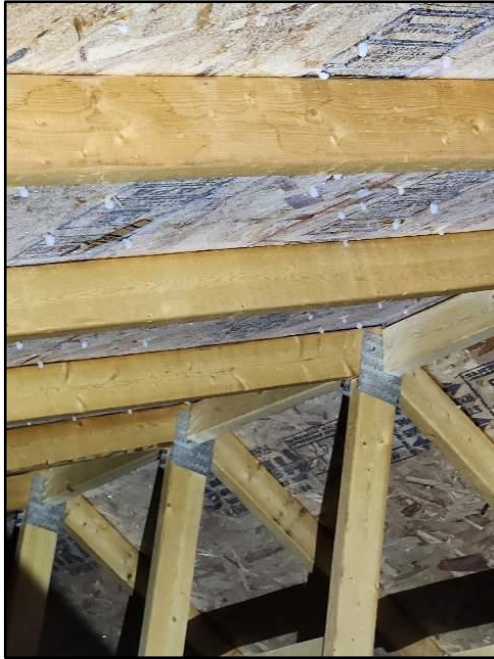
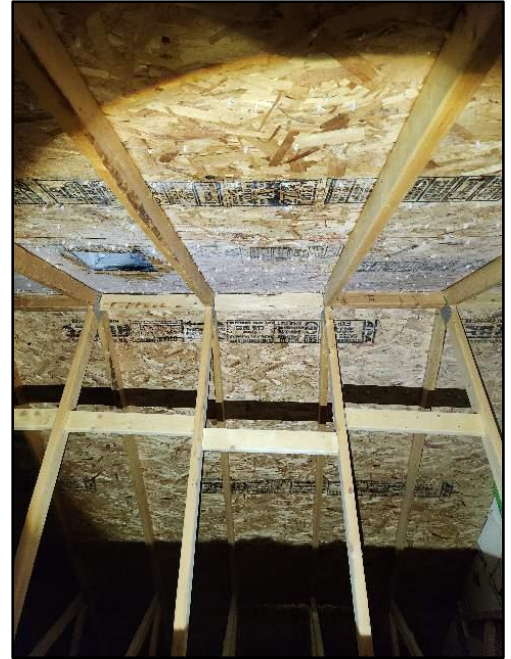
- **Water damage**

18. Water damage

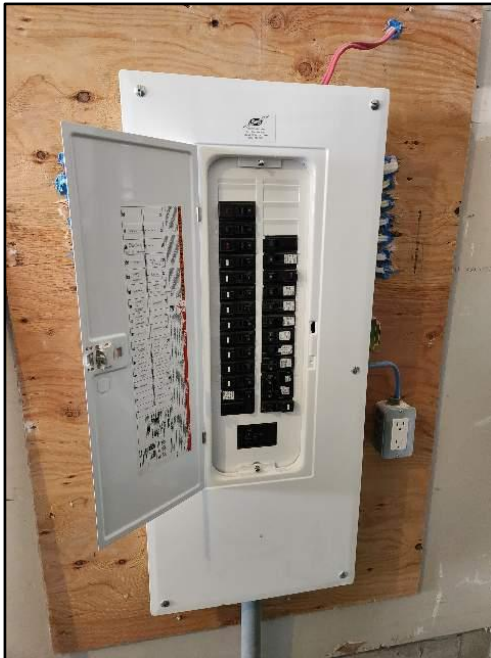
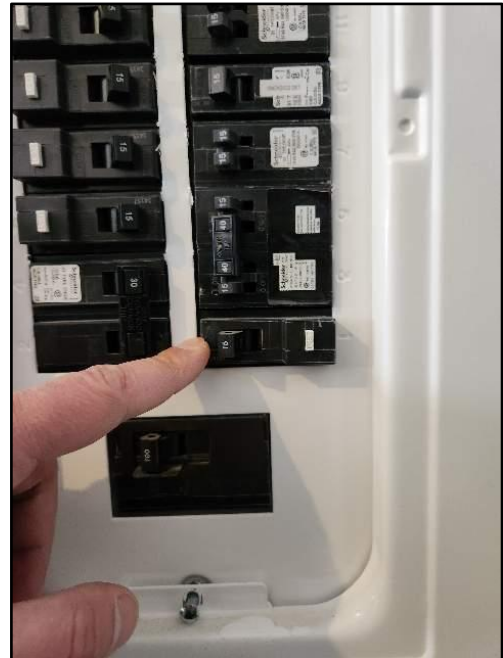
24. Loose breakers or fuses

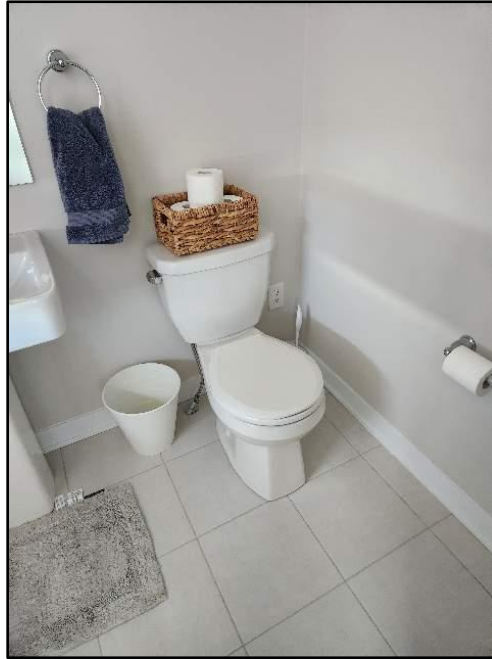
26. Loose

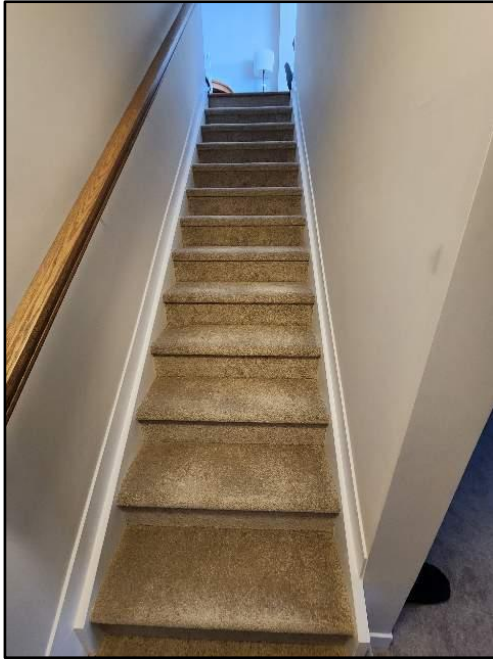
27. Buckled

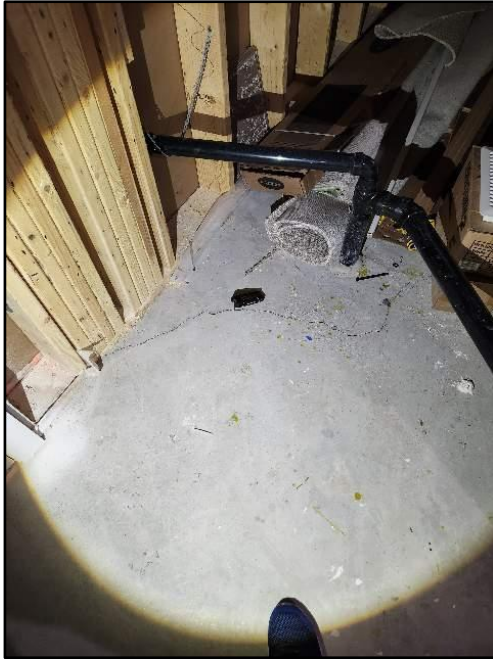
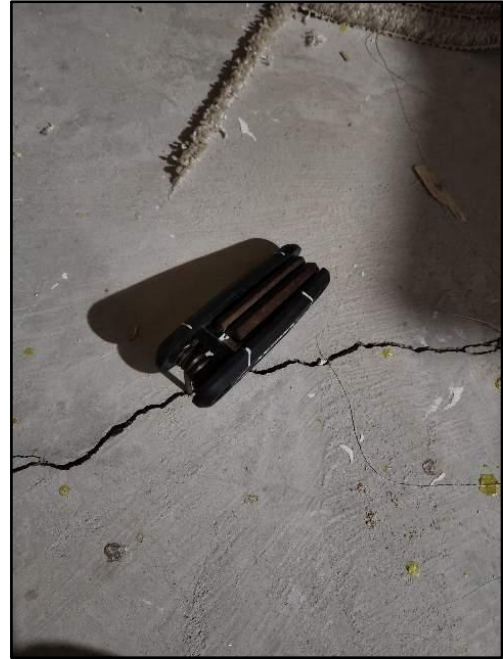
29. Cracked

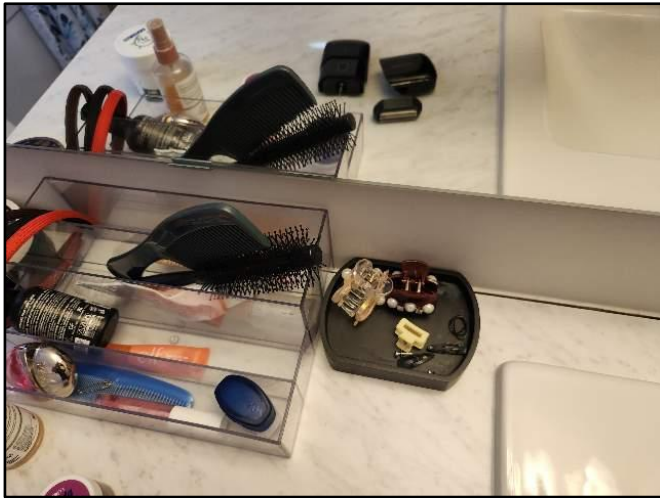
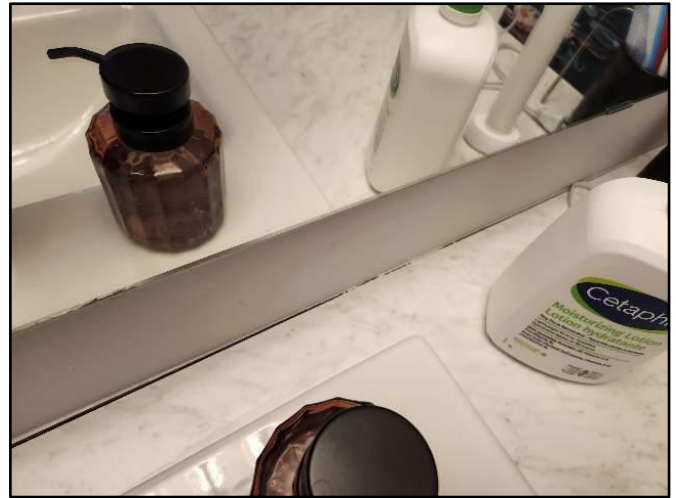
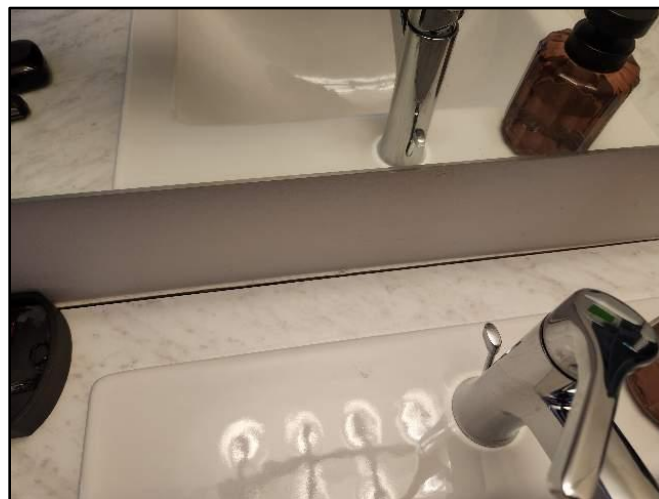
35. Caulking missing or ineffective

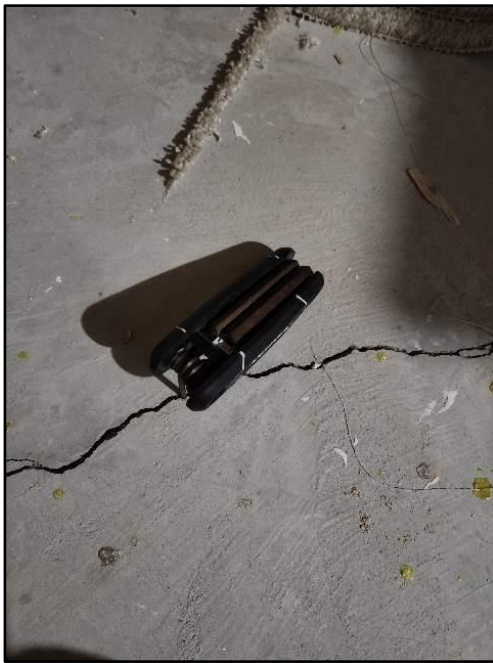
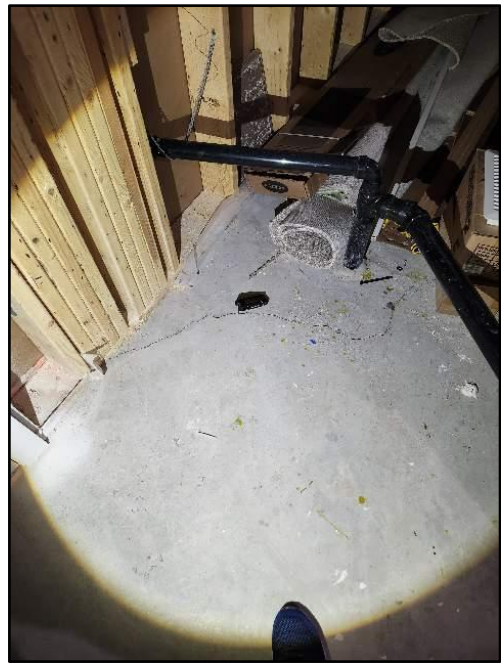
56. 1.4 Concrete basement floor is cracked.

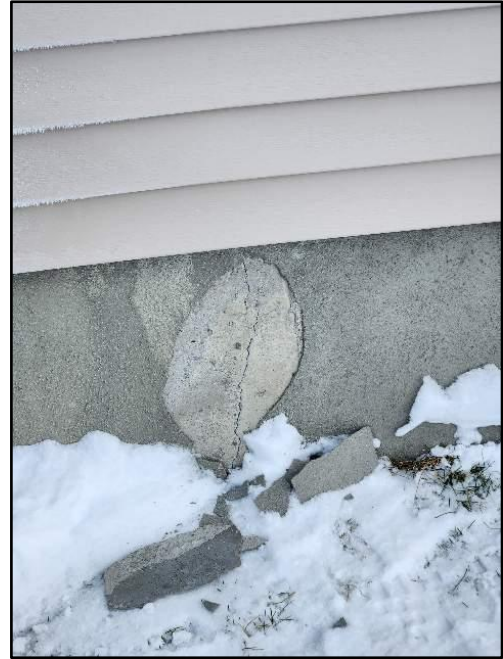
- **1.8 Parging (not brush coating) is falling off above grade.**
  - Condition: Parging is separating or falling off the above-grade portion of the foundation.
  - Acceptable Standard: Hairline cracks are normal; parging separating from the block base is not acceptable.
  - Required Action: Parging not meeting the acceptable condition shall be repaired.
  - Remarks: Parging is required only on block walls below grade. Brush coating on poured walls is cosmetic and covered separately. Colour/texture variation in repairs is normal.

59. 1.8 Parging (not brush coating) is falli

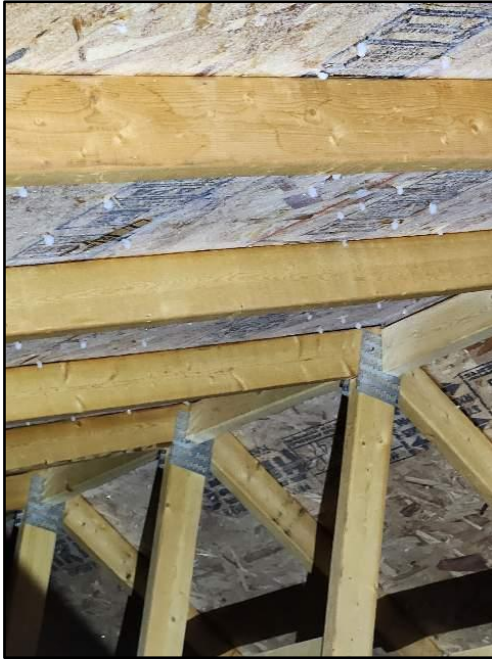
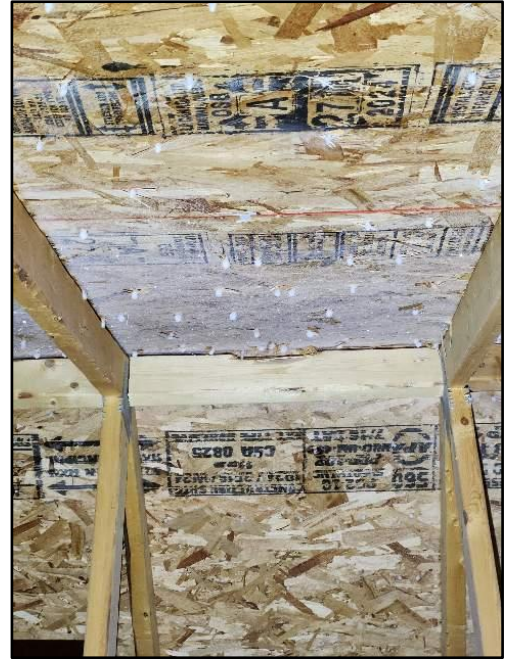
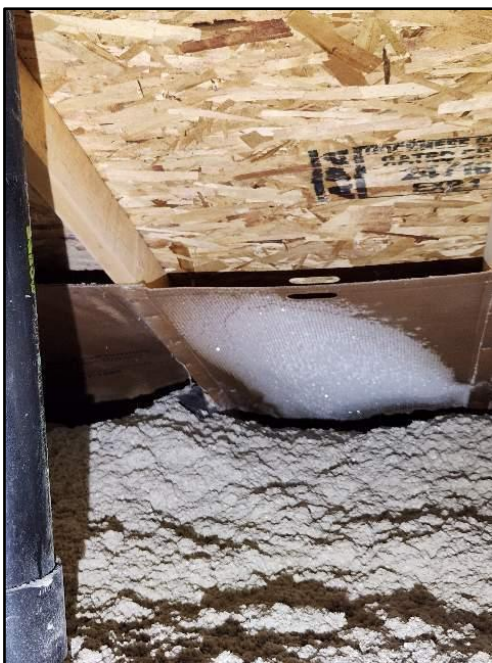
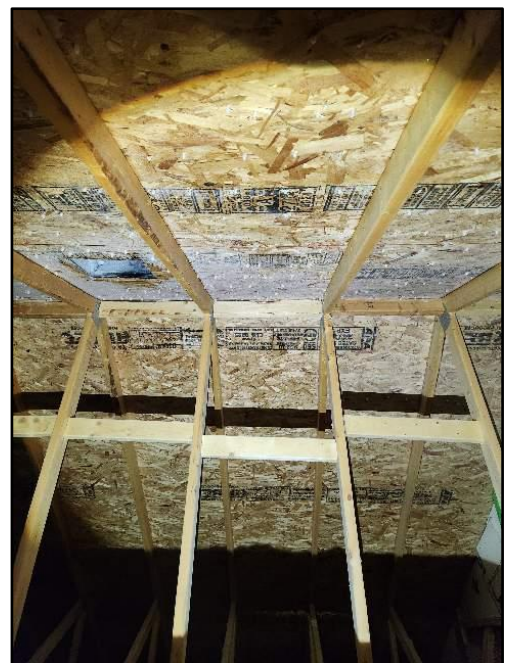
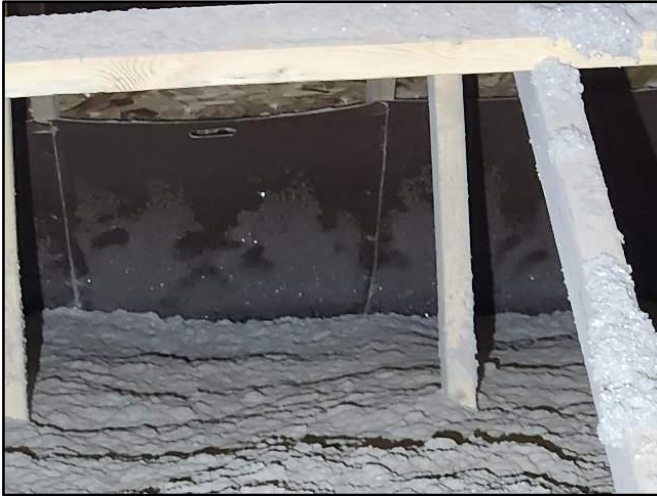
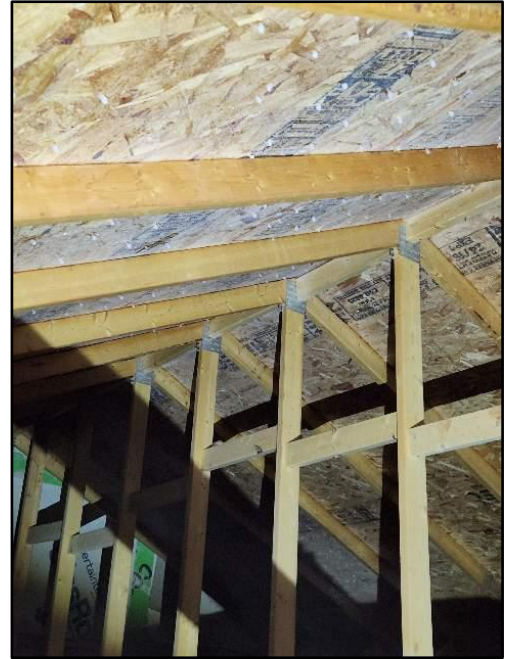
63. 5.0 Missing, Incomplete or Damaged Items

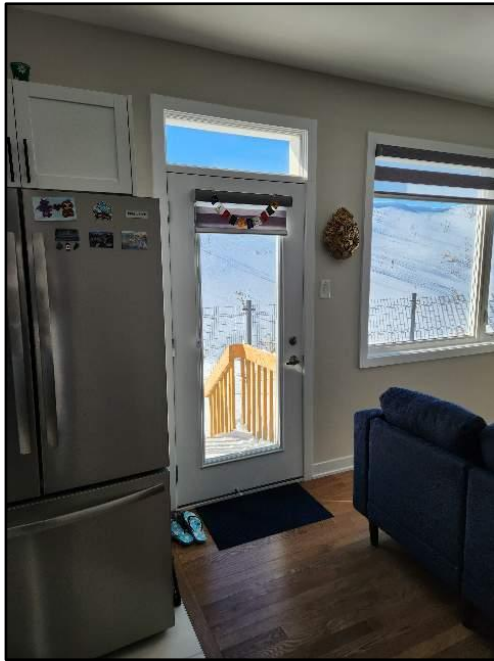
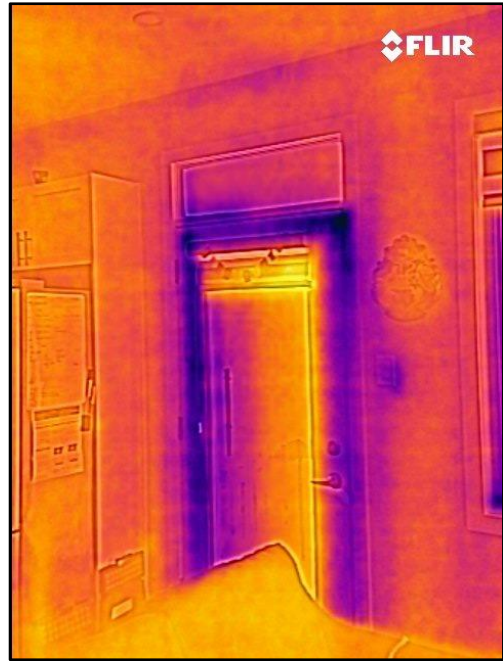
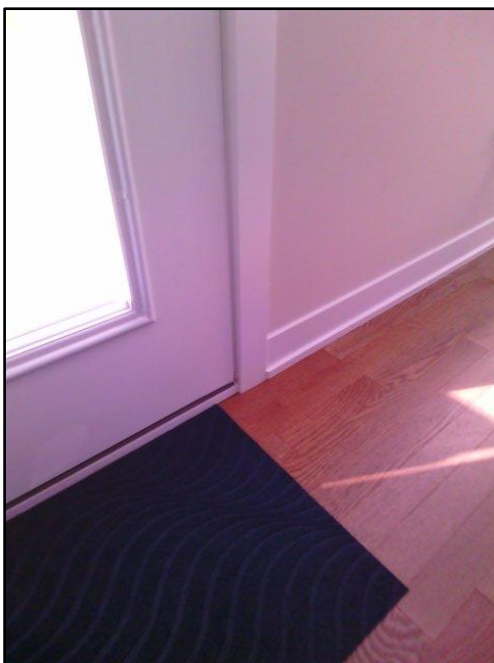
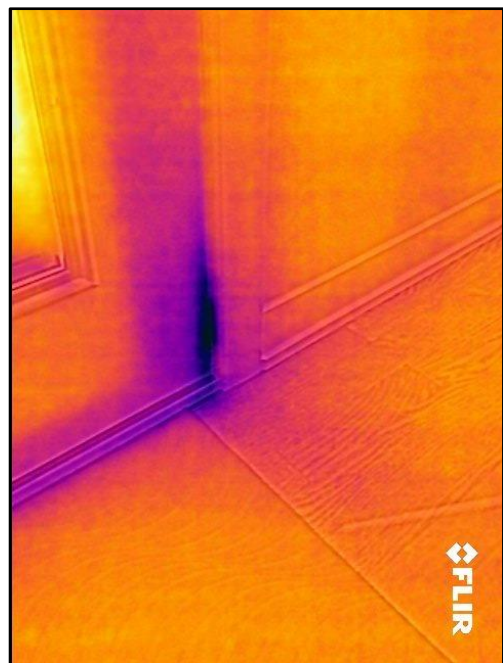
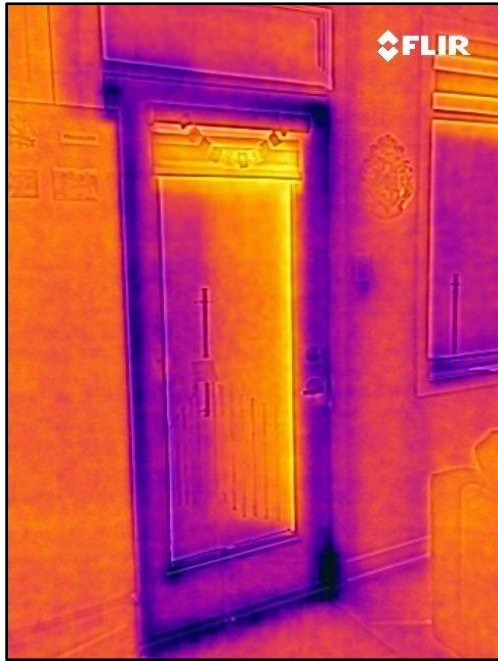
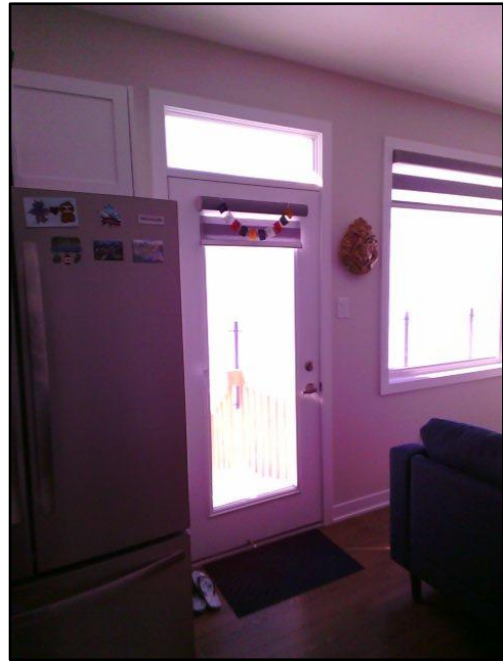
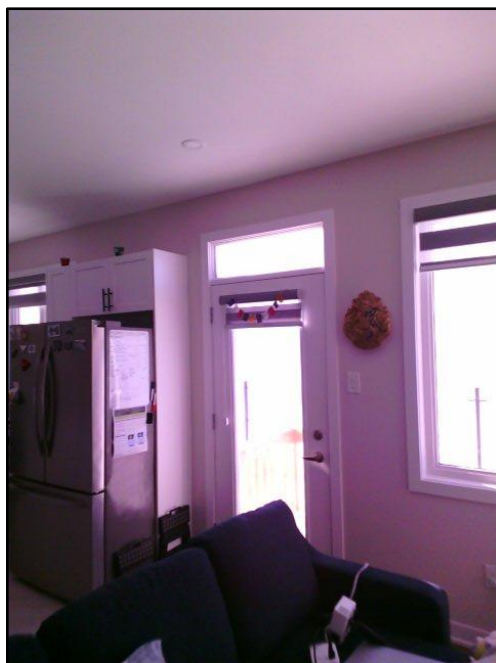
73. 8.2 Air infiltration through windows and

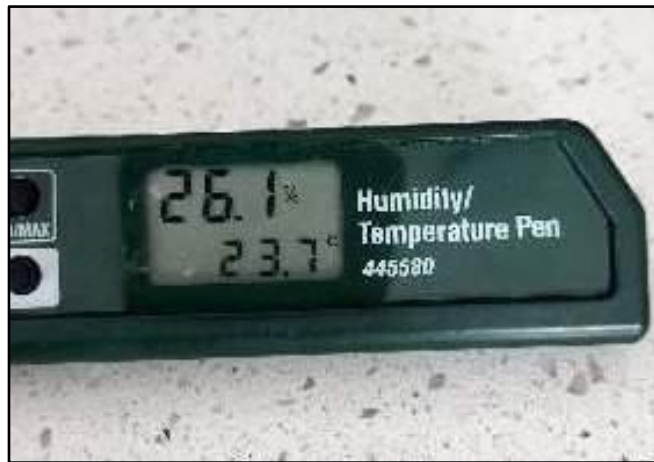
80. 8.5 Condensation and/or frost on windows

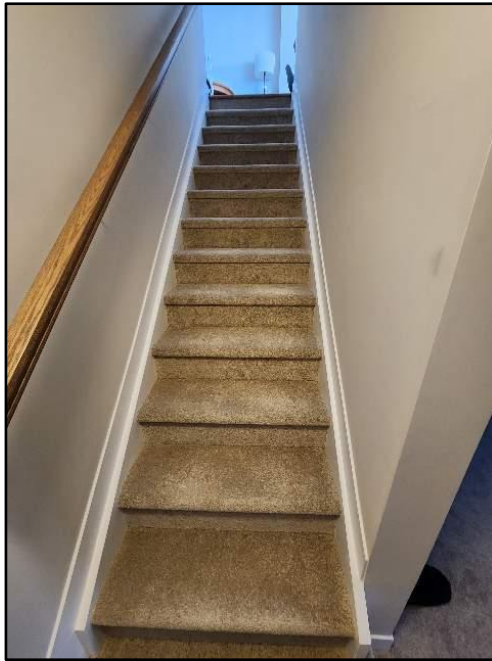
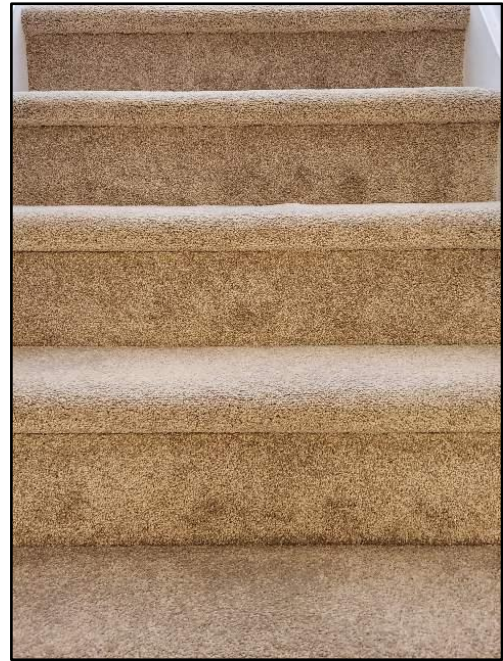
86. 12.5 Carpet is loose or stretching has o
