# Inspection Report

**Avelar Home Inspection Inc.**  
We see what you can't.

Inspection Date:  
February 13, 2026

For the property at:  
123 Sample Road, Ottawa, Ontario

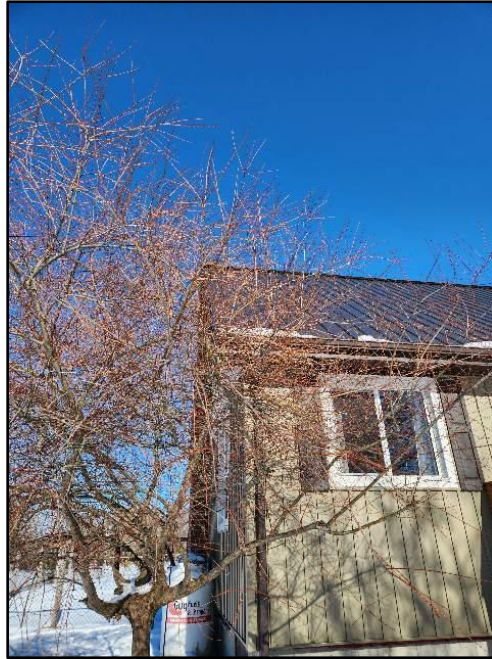
During the inspection, the inspector observed tree branches in contact with the roof surface.

Overhanging or touching branches can cause physical damage to roofing materials through abrasion, especially during windy conditions. Repeated contact may lead to shingle granule loss, coating deterioration, or puncture risk on metal panels.

1. Tree branches touching roof

The inspector recommends trimming or removal of the affected branches by a certified arborist to prevent further damage and maintain proper roof performance and safety.

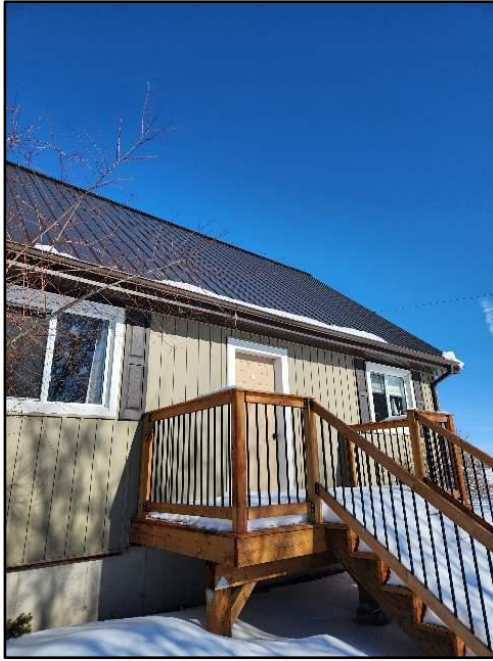
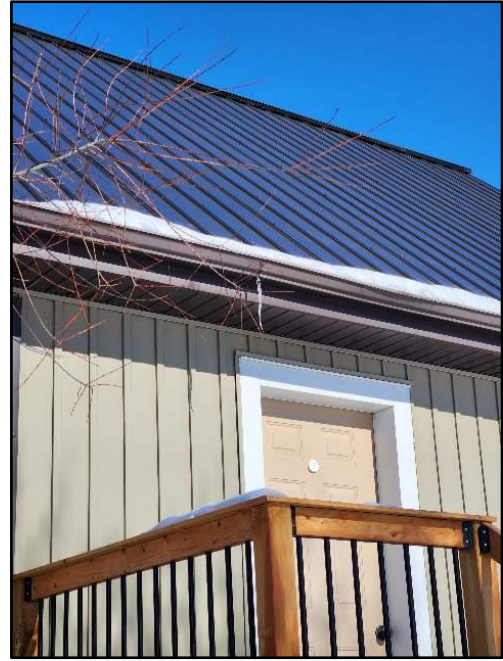
During the inspection, the inspector observed signs of leakage affecting one or more sections of the gutter system.

Leaks may result from seam separation, corroded joints, damaged end caps, or improper alignment with the drip edge, especially in climates with freeze-thaw cycles, seasonal temperature swings, and acidic precipitation.

8. Leak

9. Leak

The inspector recommends evaluation by a reputable contractor experienced in roof drainage systems to determine whether seam resealing, hardware replacement, or system upgrade is warranted to restore proper water management and long-term building protection.

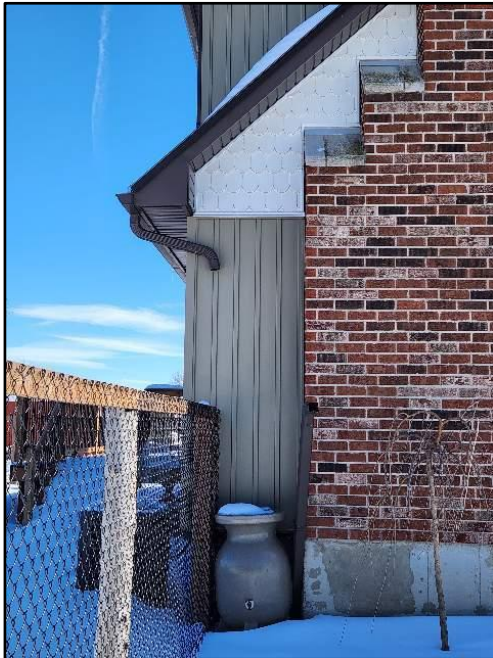
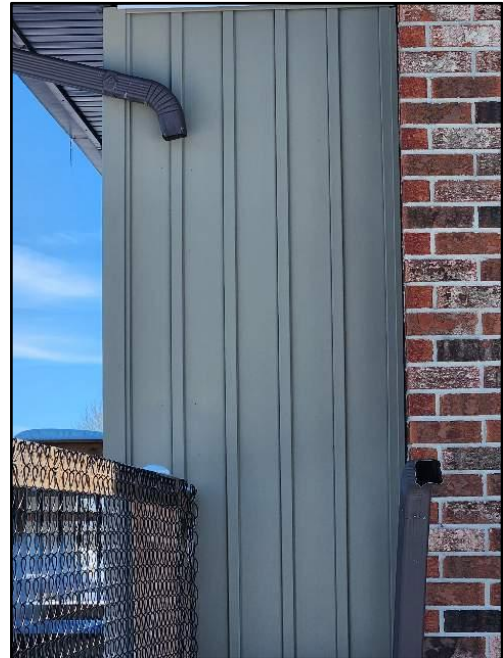
During the inspection, the inspector observed loose or partially disconnected connections in one or more downspouts.

10. Connections loose

11. Connections loose

The inspector recommends evaluation by a reputable contractor experienced in roof drainage systems to determine whether re-securing, hardware replacement, or system upgrade is warranted to restore proper water management and long-term building protection.

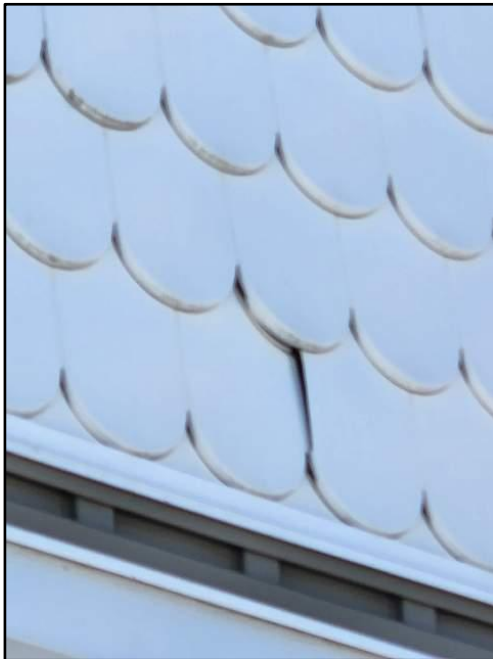
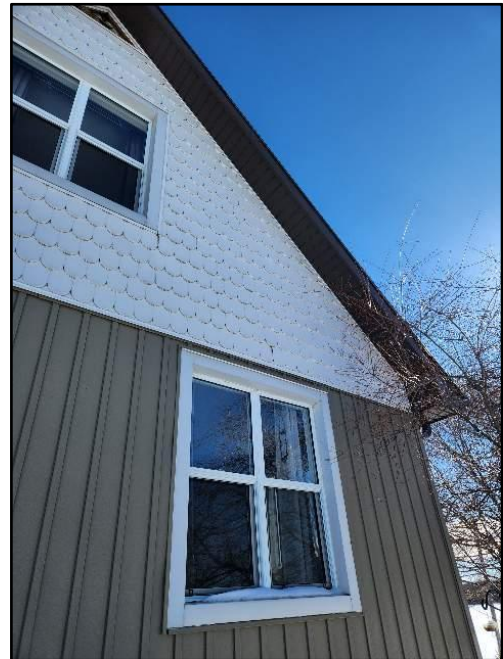
During the inspection, the inspector observed one or more vinyl siding components that were loose or missing.

14. Loose or missing pieces

15. Loose or missing pieces

The inspector recommends evaluation by a reputable contractor experienced in vinyl cladding systems to determine whether panel replacement, fastener upgrade, moisture mitigation, or system redesign is warranted to restore proper protection and long-term building performance.

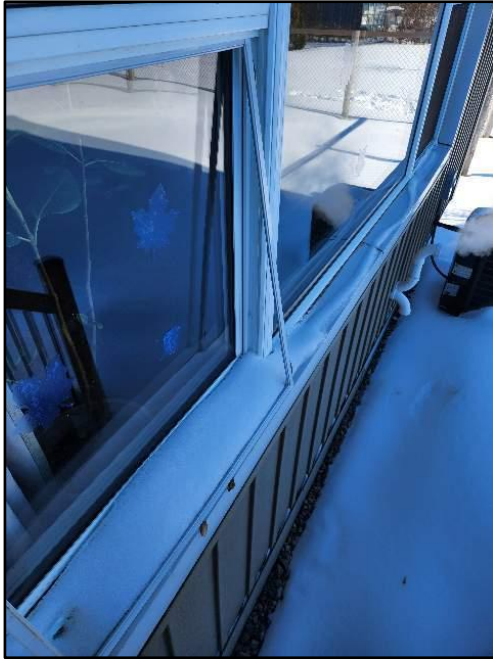
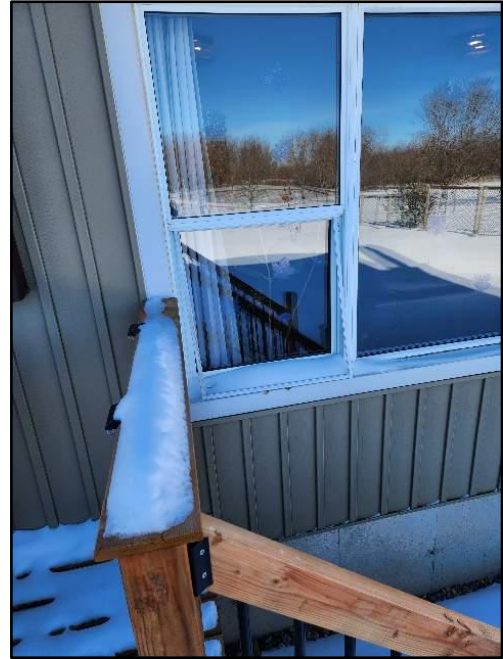
During the inspection, the inspector observed that one or more exterior window screens were missing.

16. Missing

17. Missing

The inspector recommends evaluation by a qualified window contractor or screen specialist to determine whether screen replacement, frame installation, or protective upgrades are warranted to restore proper safety, performance, and appearance.

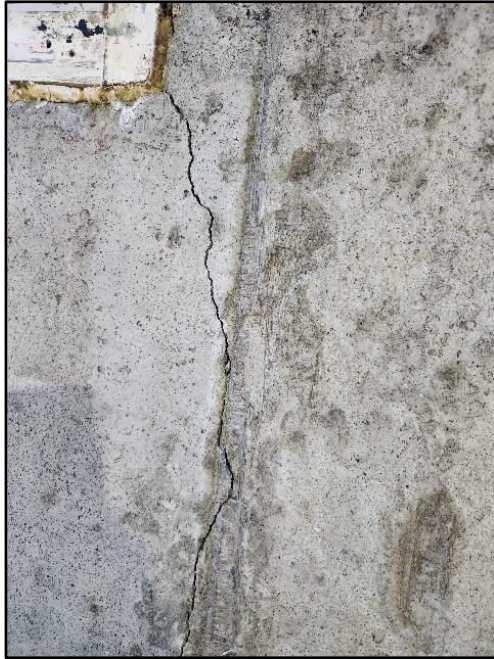
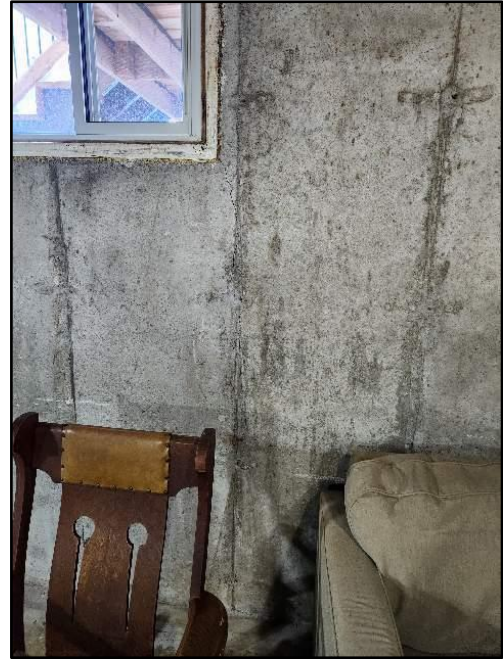
24. Typical minor cracks

25. Typical minor cracks

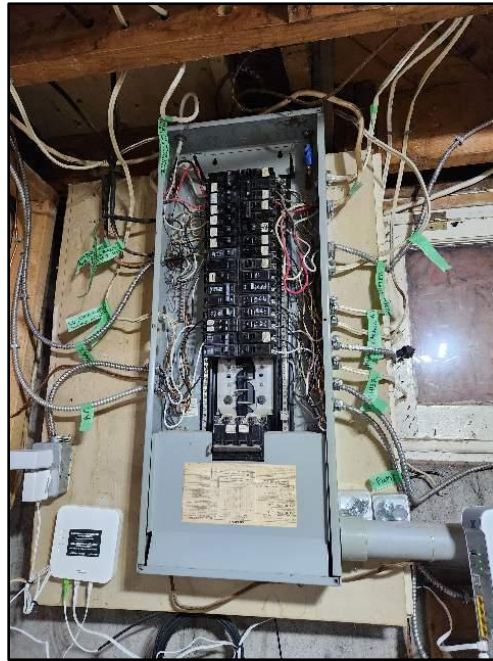
42. Loose breakers or fuses

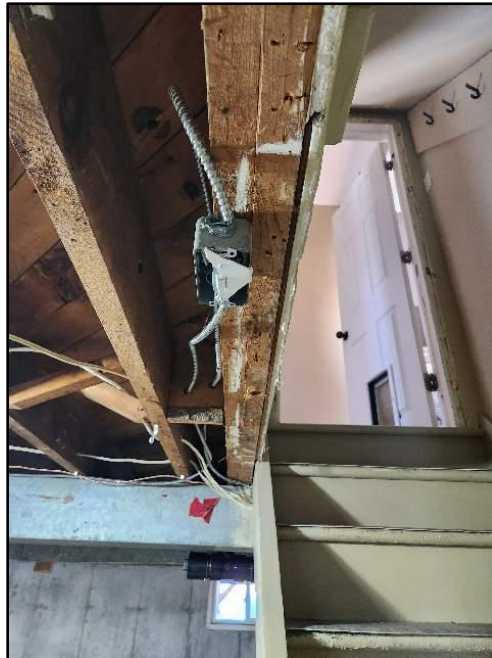
46. For switch is damaged

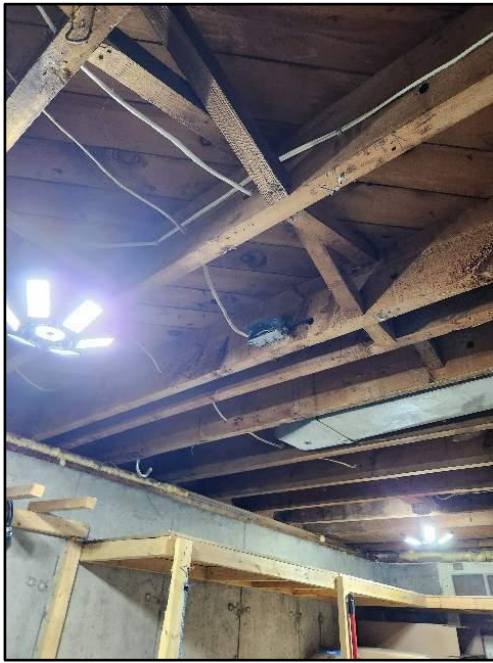
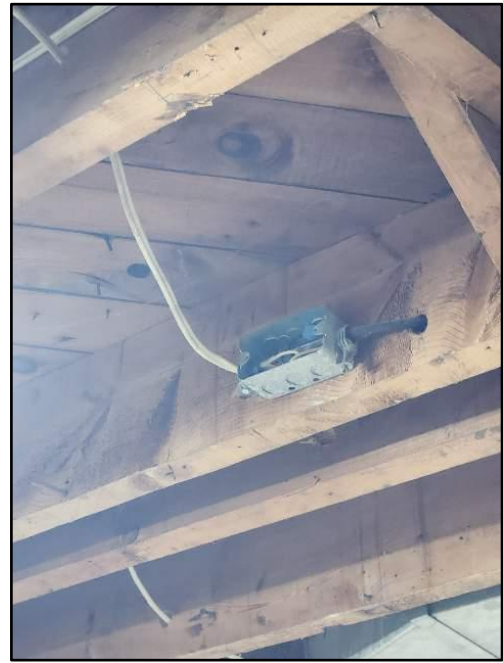
47. For junction box is missing

48. For junction box is missing

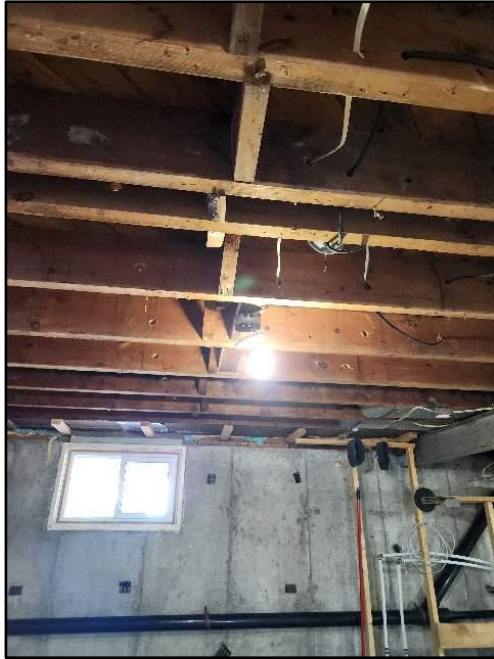
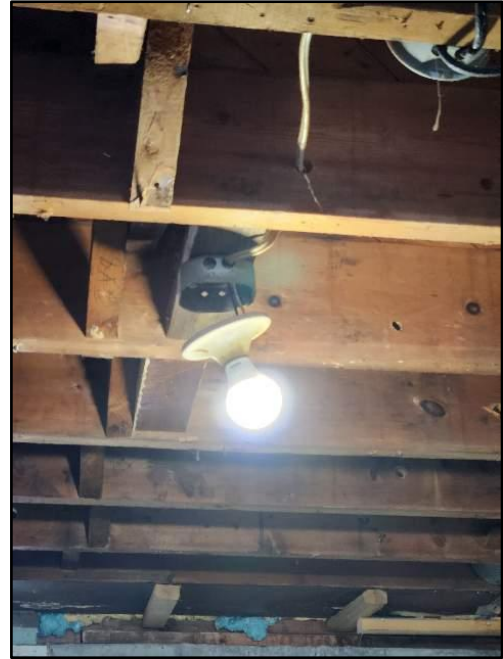
During the inspection, the inspector observed that one or more light fixtures were loose, indicating potential mechanical instability, electrical hazard, or installation deficiency.

49. Loose

50. Loose

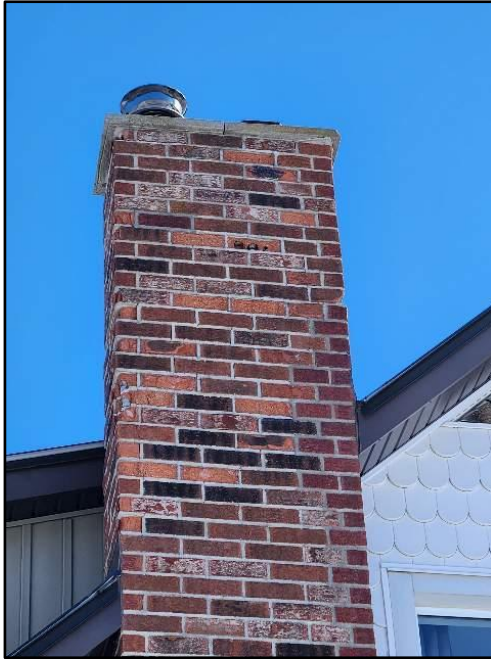
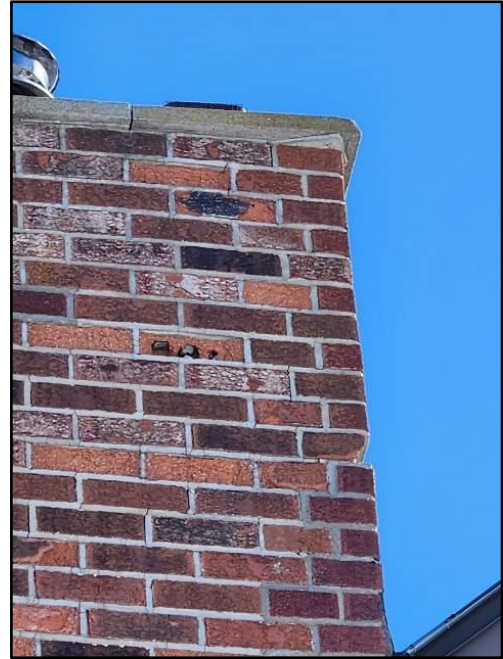
51. Loose, missing or deteriorated masonry

52. Loose, missing or deteriorated masonry

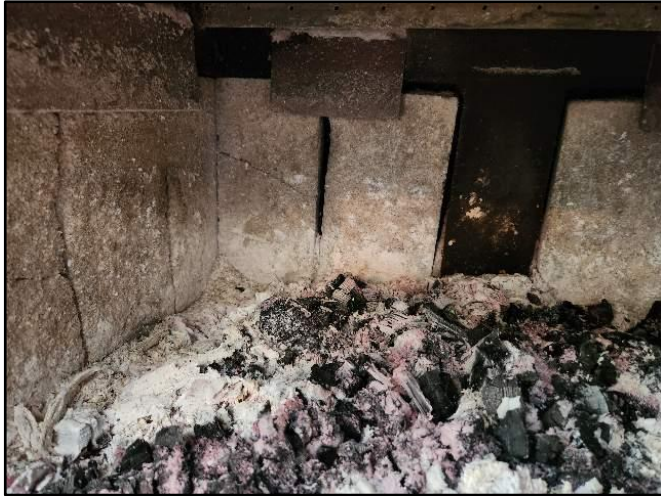
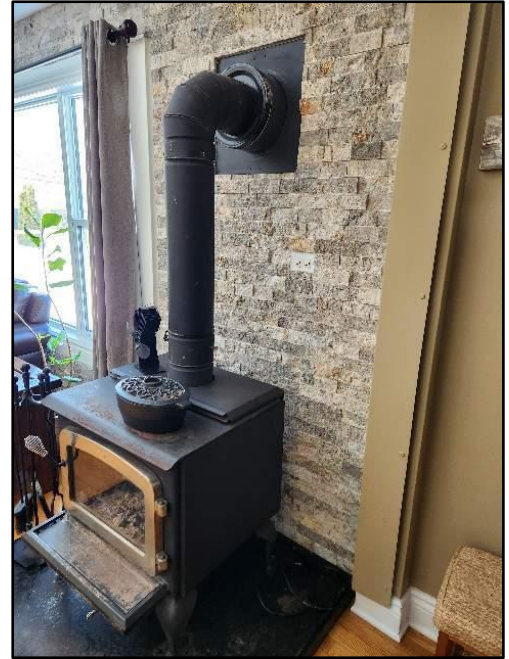
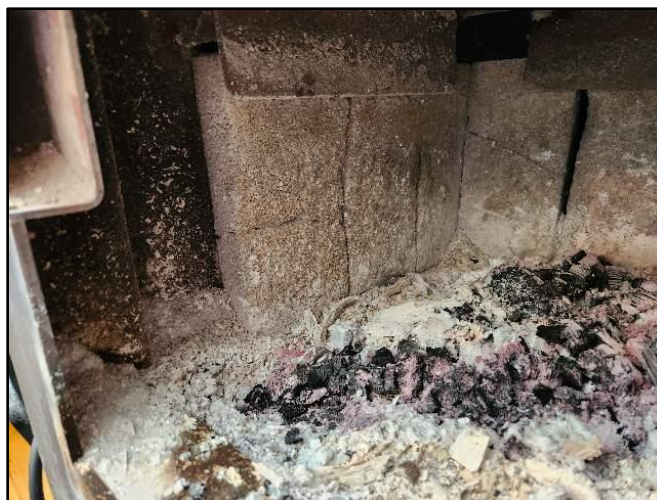
61. Firebrick cracked, crumbling or incomplete

62. Firebrick cracked, crumbling or incomplete

63. Firebrick cracked, crumbling or incomplete

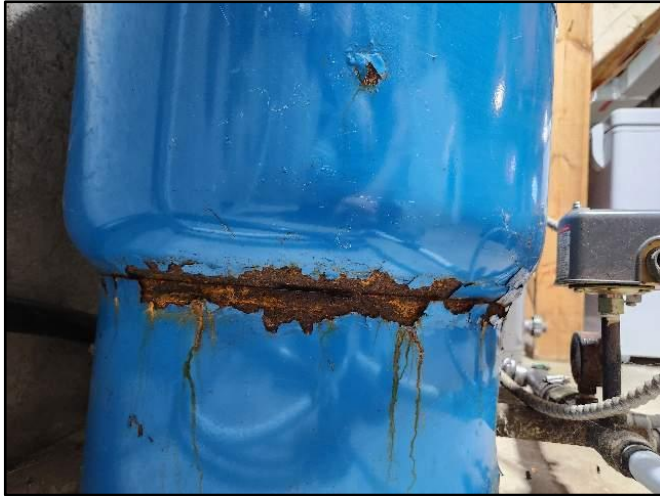
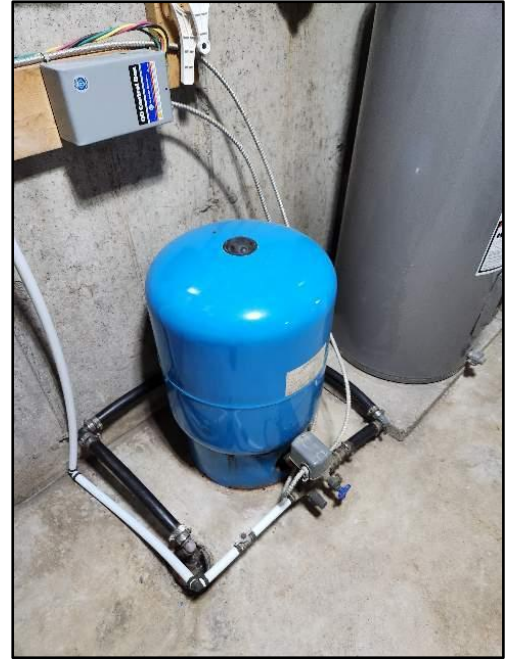
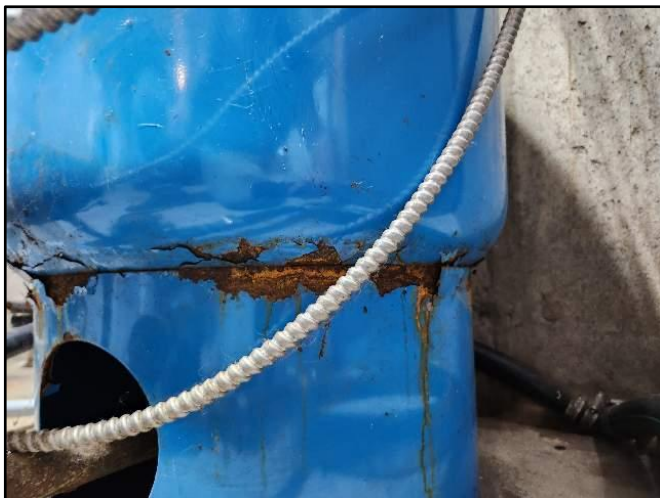
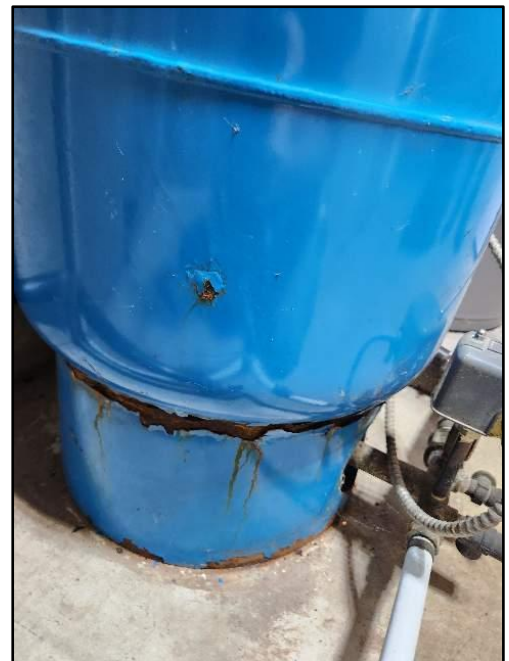
74. Rust

75. Rust

76. Rust

77. Rust

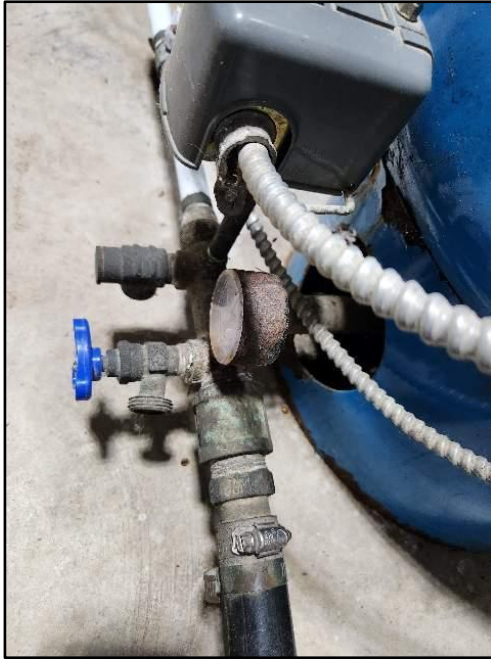
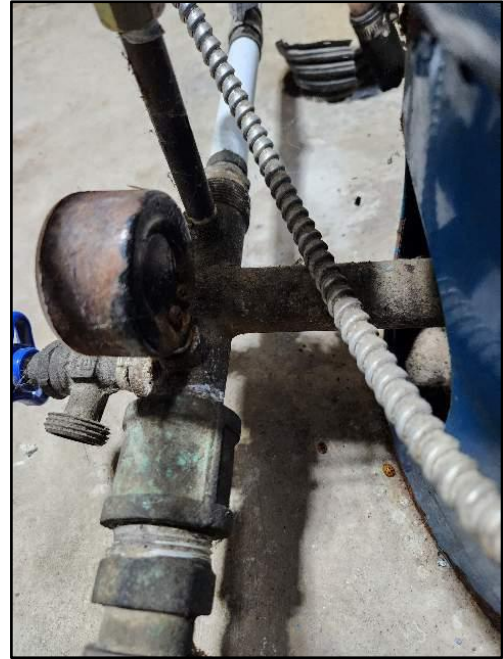
78. Rust

79. Rust

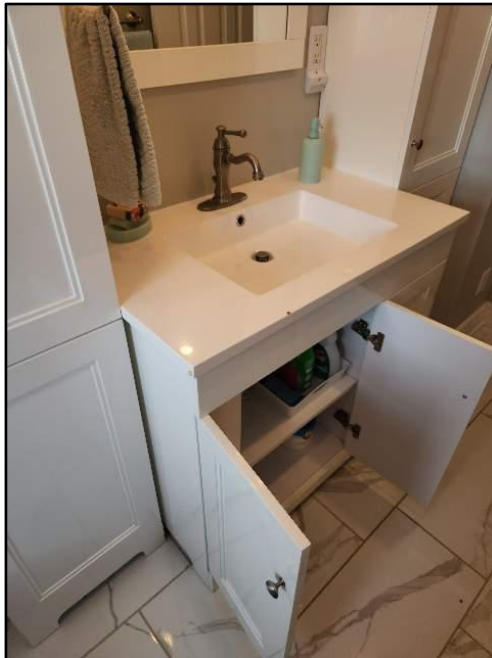
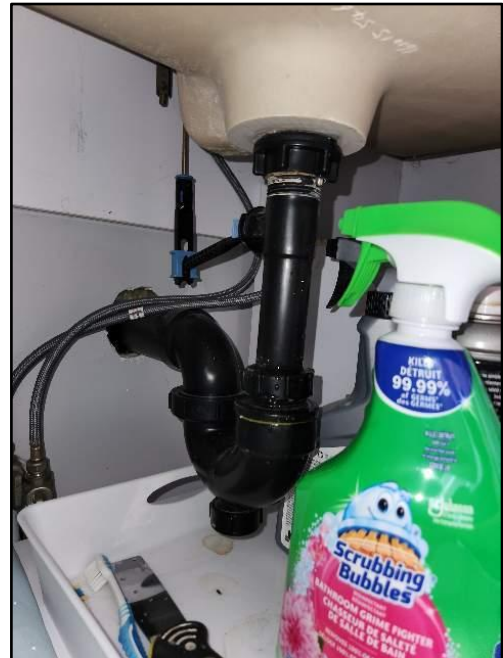
80. Leak

81. Leak

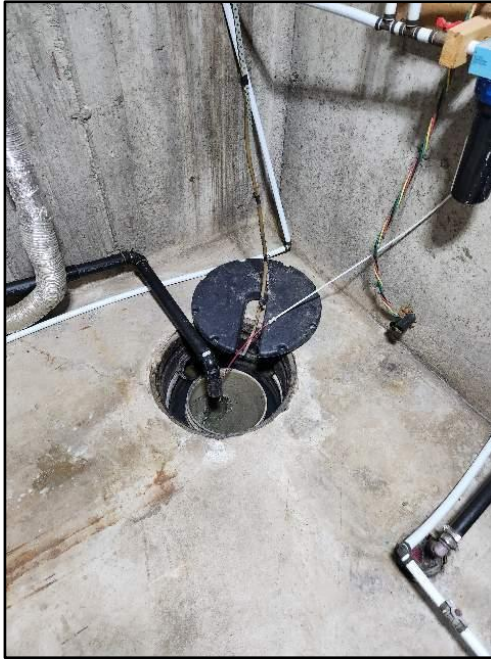
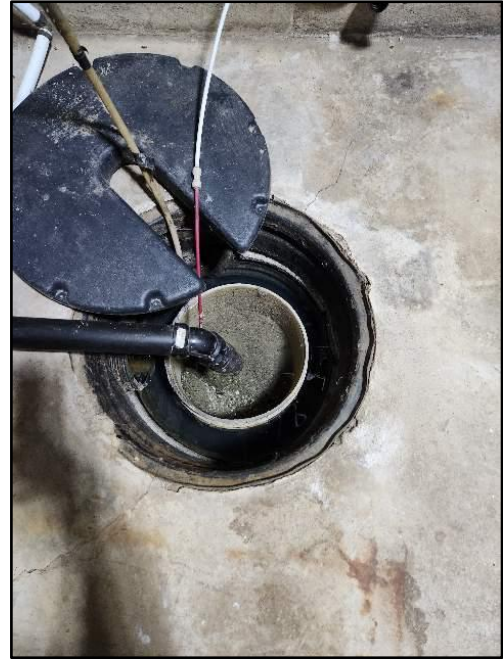
82. Missing

83. Missing

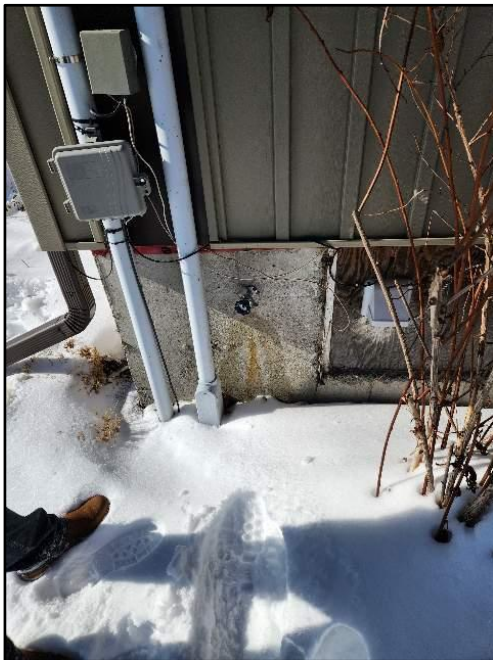
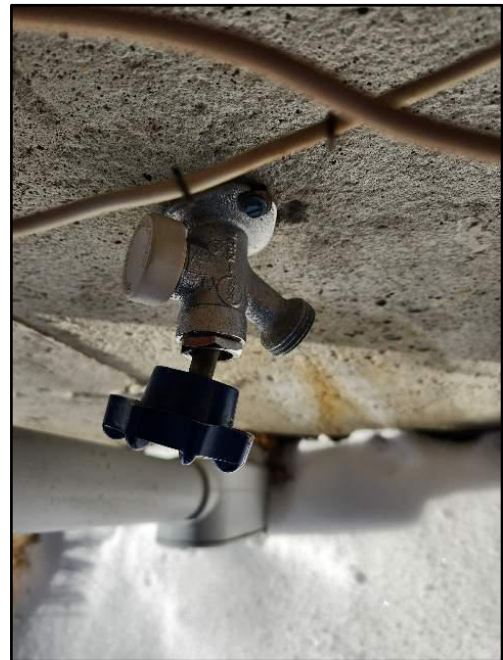
84. Damage

85. Damage

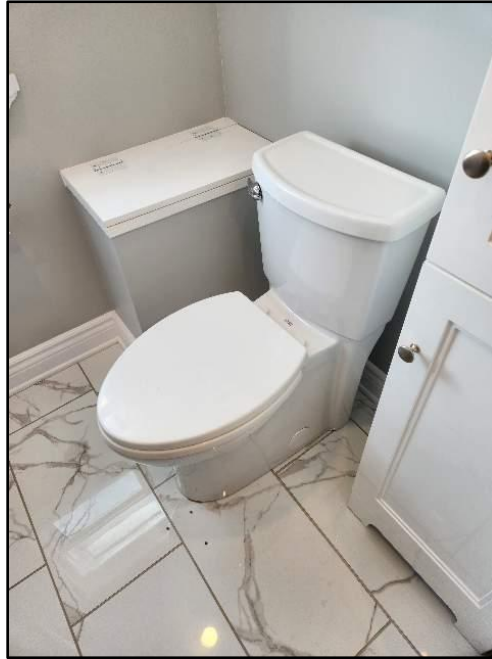
86. Loose

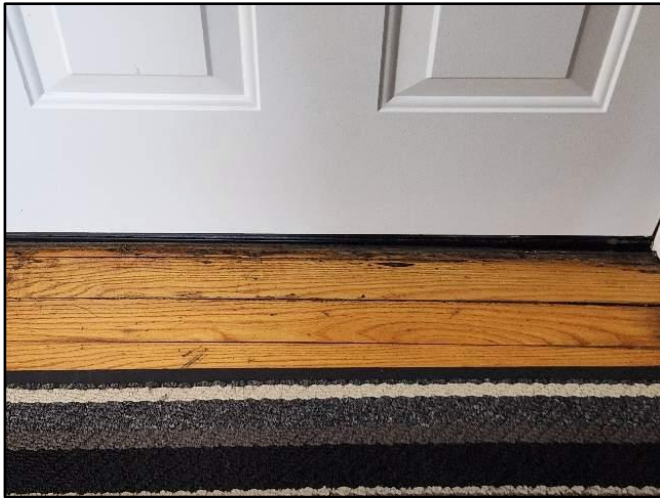
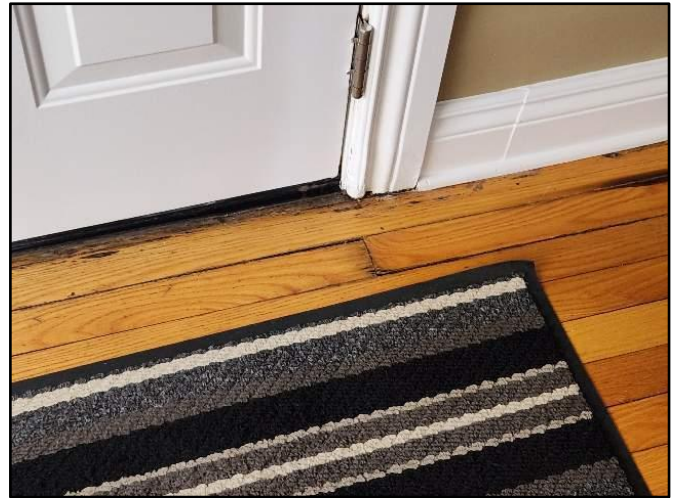
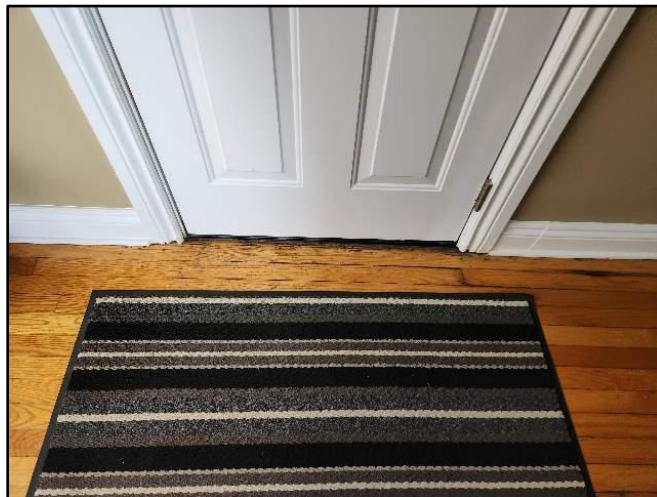
During the inspection, the inspector observed signs of water damage affecting flooring materials. Water intrusion can compromise both the structural integrity and appearance of floors, especially in materials that are not designed to

87. Water damage

88. Water damage

89. Water damage

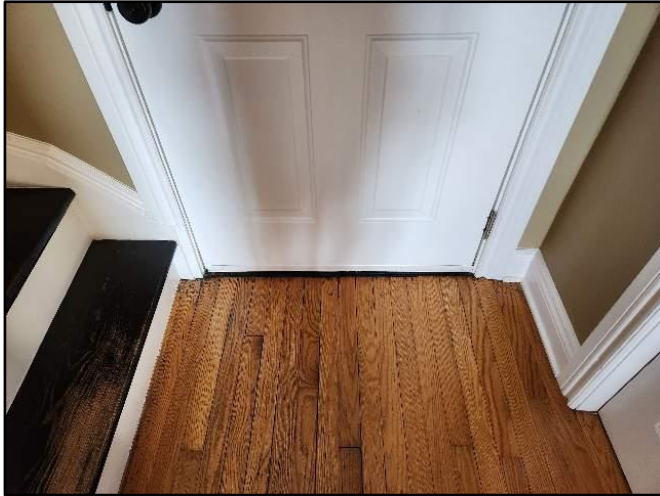
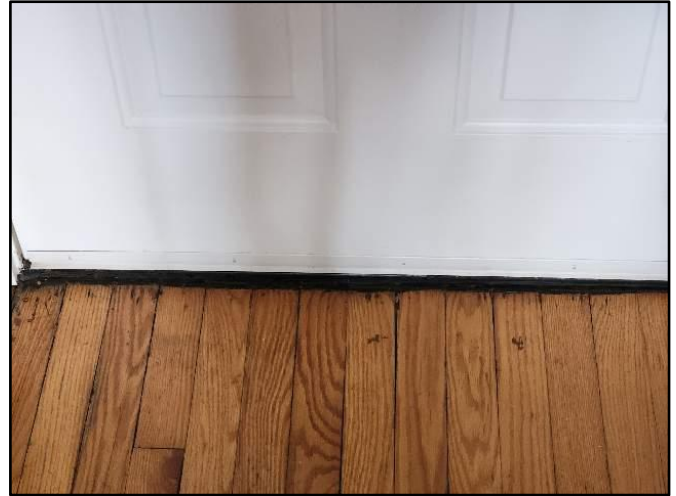
90. Water stains

91. Water stains

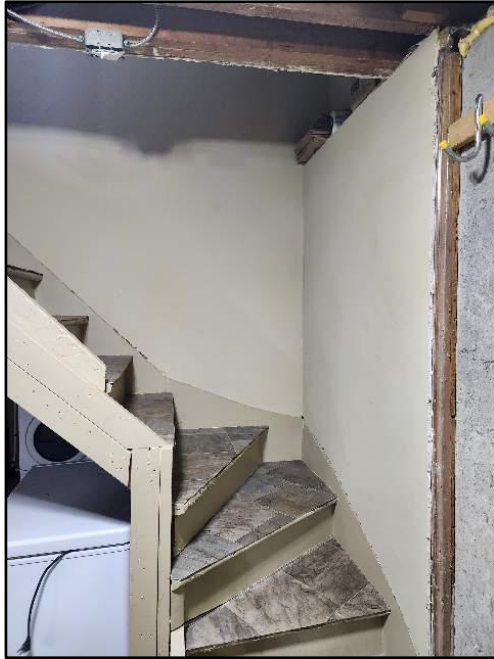
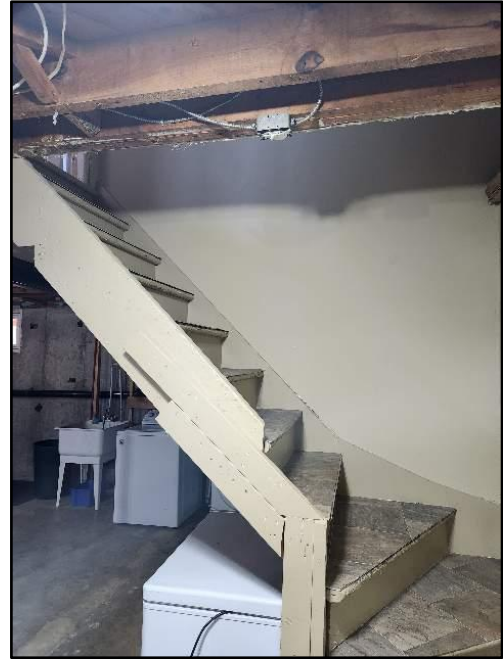
93. Missing

94. Missing

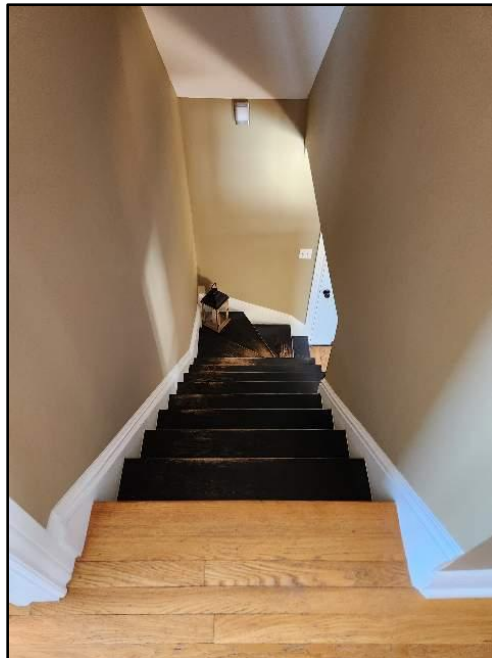
Best practices require handrails on at least one side of interior stairs with four or more risers, and guards on open sides of stairs or landings more than 30 inches above the floor. The inspector recommends evaluation by a qualified contractor to determine whether handrails or guards should be installed to improve safety and ensure code compliance.

95. Missing
