# Inspection Report

**Avelar Home Inspection Inc.**  
We see what you can't.

January 29, 2026

1234 Sample Road, Ottawa,  
Ontario, K1K 1K1

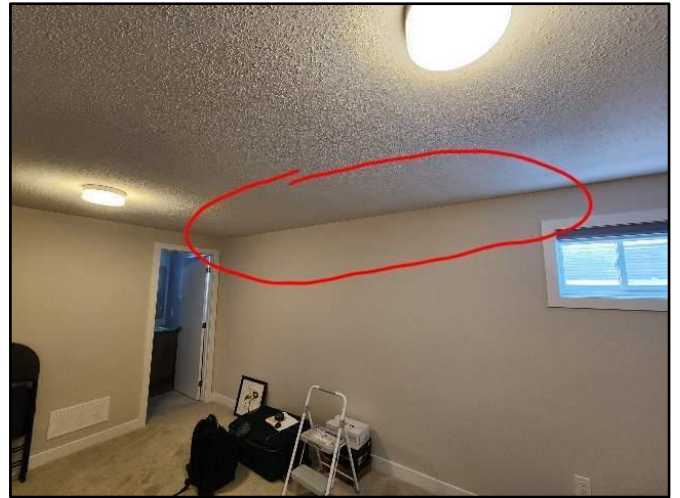
39. No elevated moisture found with meter

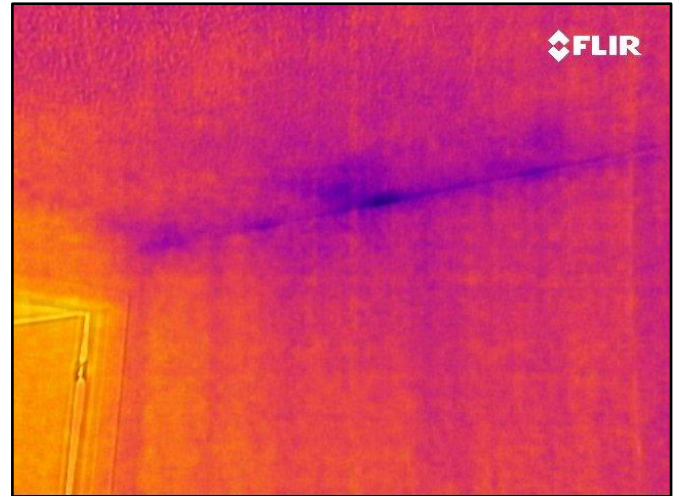
43. No elevated moisture found with meter

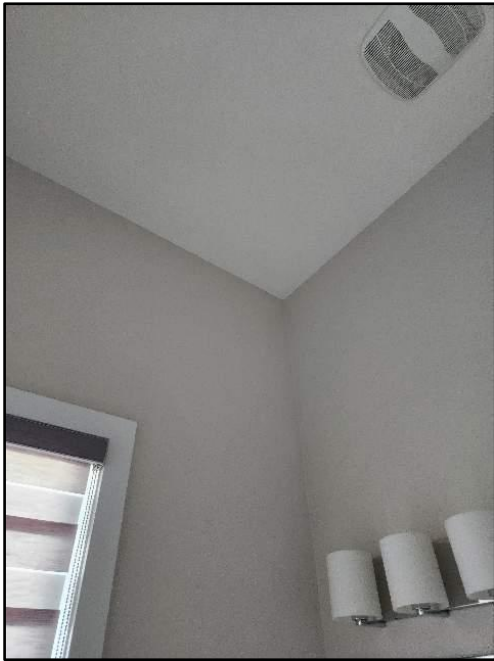
44. No elevated moisture found with meter

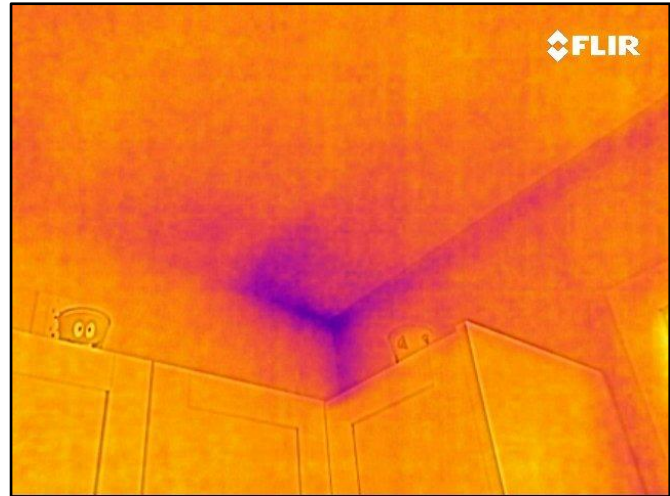
45. No elevated moisture found with meter

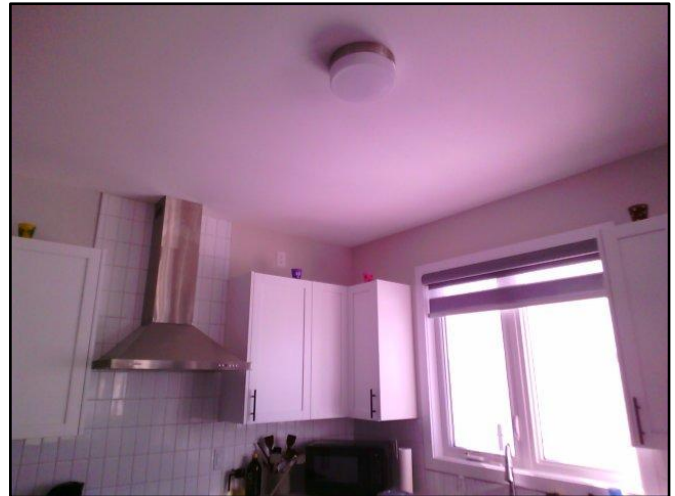
47. No elevated moisture found with meter

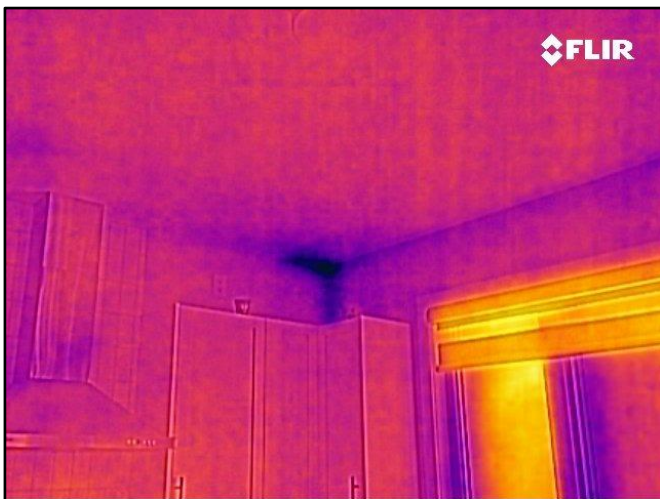
48. No elevated moisture found with meter

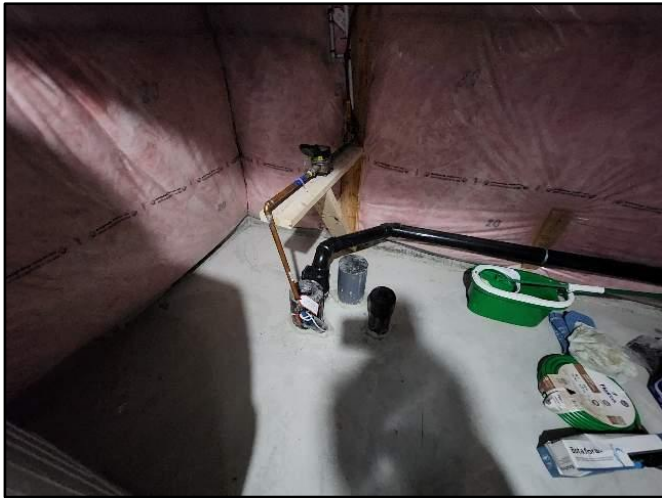
During the inspection, thermal anomalies were noted in the floor near the foundation using a FLIR C5 infrared camera. Follow-up testing with a FLIR MR60 moisture meter did not identify moisture levels above normal. These findings are consistent with thermal bridging rather than active moisture intrusion. The area should be monitored over time for any signs of staining, efflorescence, or condensation.

50. No elevated moisture found with meter

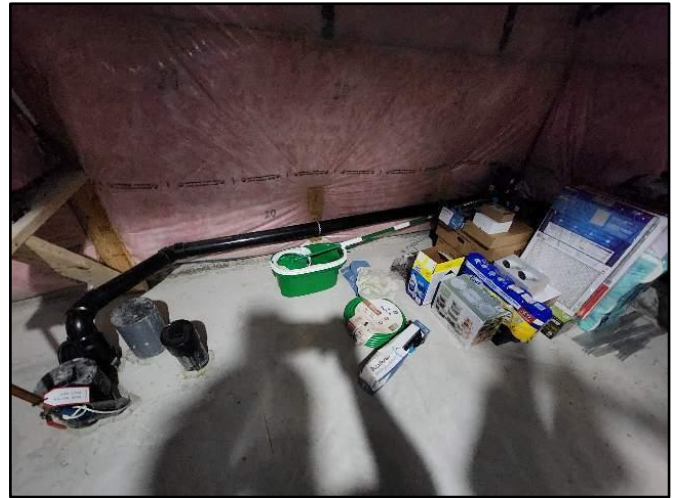
51. No elevated moisture found with meter

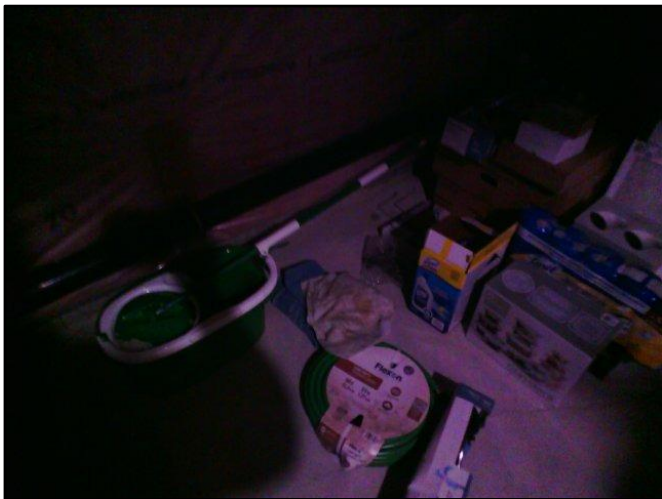
52. No elevated moisture found with meter

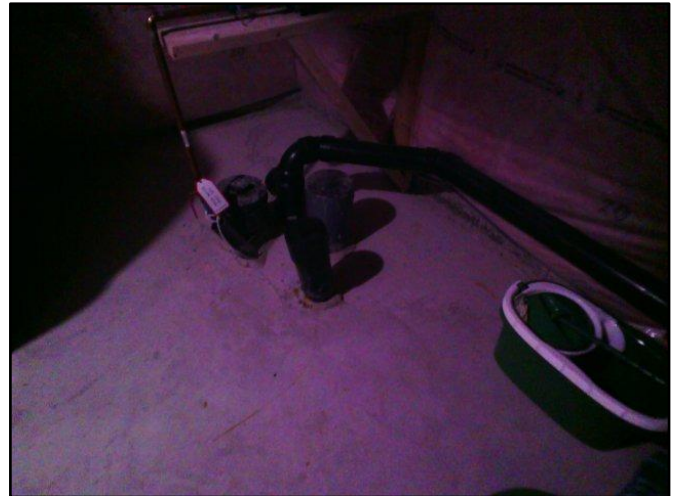
55. No elevated moisture found with meter

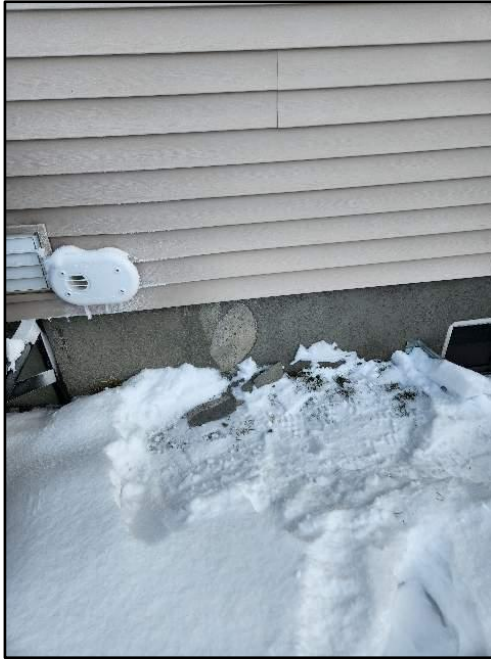
- **1.8 Parging (not brush coating) is falling off above grade.**
  - Condition: Parging is separating or falling off the above-grade portion of the foundation.
  - Acceptable Standard: Hairline cracks are normal; parging separating from the block base is not acceptable.
  - Required Action: Parging not meeting the acceptable condition shall be repaired.
  - Remarks: Parging is required only on block walls below grade. Brush coating on poured walls is cosmetic and covered separately. Colour/texture variation in repairs is normal.

58. 1.8 Parging (not brush coating) is falli

**TASK:** Submit to Tarion for review

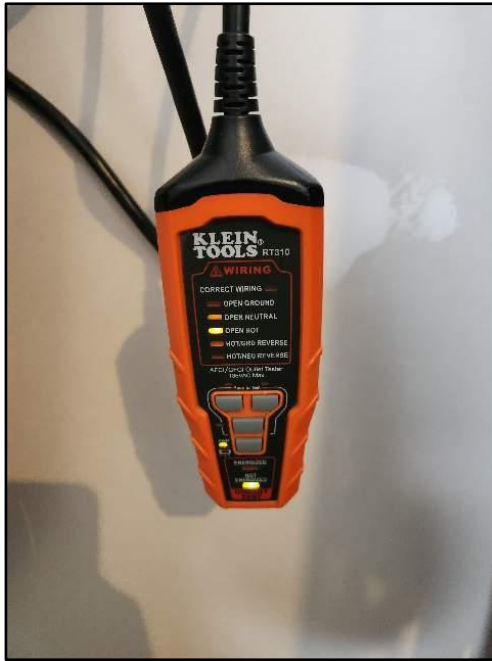
69. 7.1 Fuses blow or circuit breakers trip.

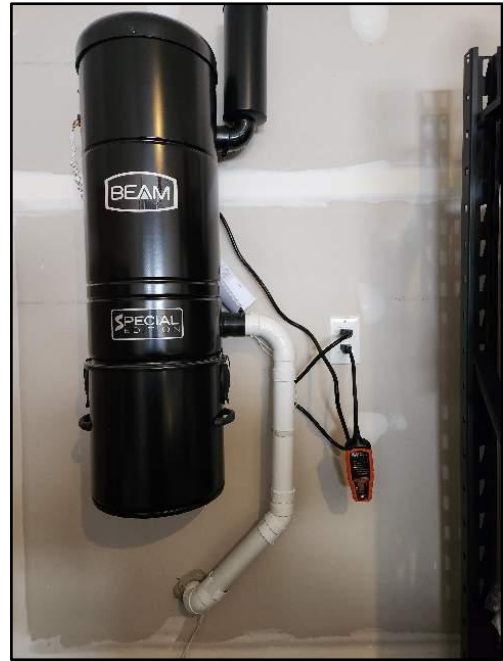
70. 7.1 Fuses blow or circuit breakers trip.

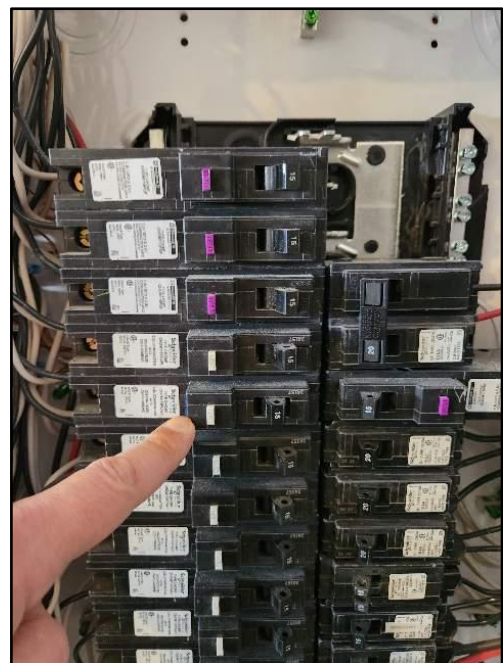
72. 7.1 Fuses blow or circuit breakers trip.
