# Inspection Report

**Avelar Home Inspection Inc.**  
We see what you can't.

Inspection Date:  
February 13, 2026

For the property at:  
123 Sample Road, Ottawa, Ontario

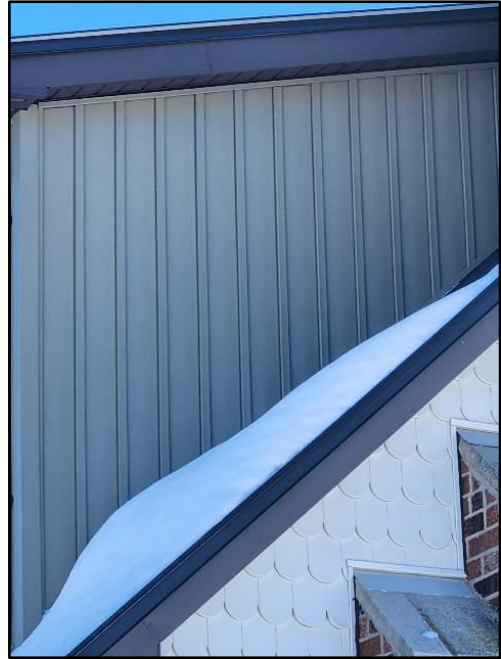
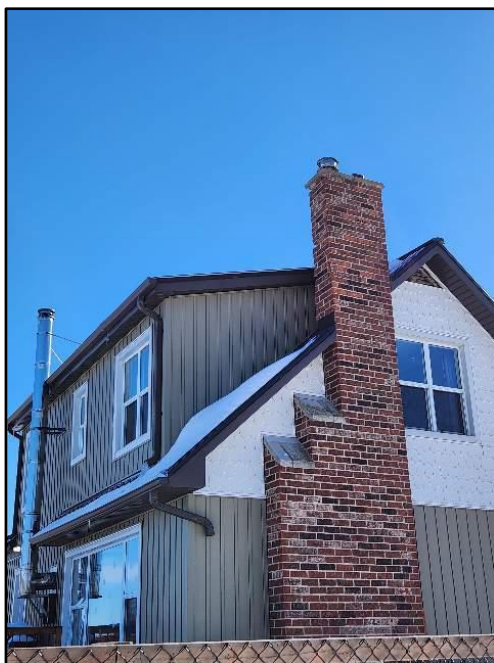
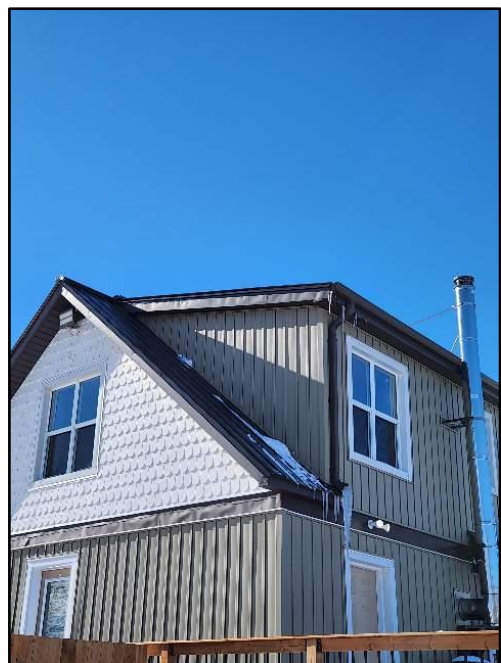
During the inspection, the inspector observed that siding was not adequately cut back from the roof surface at one or more roof/sidewall flashing locations.

Best practices recommend that siding be cut back a minimum of 1½ to 2 inches above the roof surface to allow for proper flashing installation and to prevent moisture wicking, rot, and sealant failure.

When siding contacts or overlaps the roof, it can trap water and debris, obstruct flashing, and accelerate deterioration of both the siding and roofing materials — especially in climates with freeze-thaw cycles, snow accumulation, or wind-driven rain.

4. Siding not cut back

The inspector recommends evaluation by a reputable roofing or exterior contractor to determine whether cutting back the siding and properly integrating flashing is warranted to restore long-term weather protection and prevent future damage.

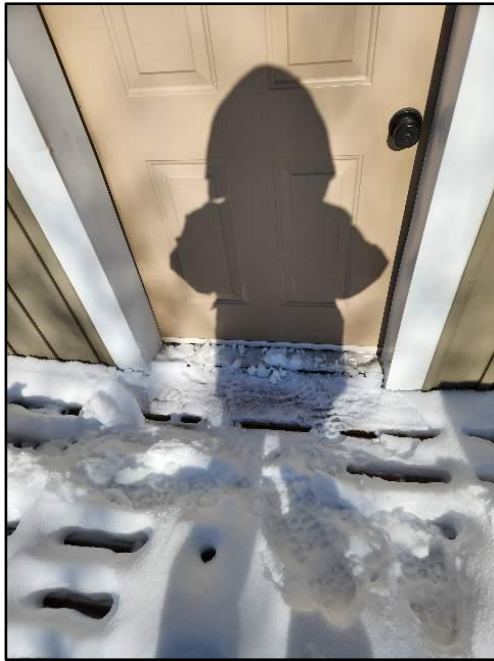
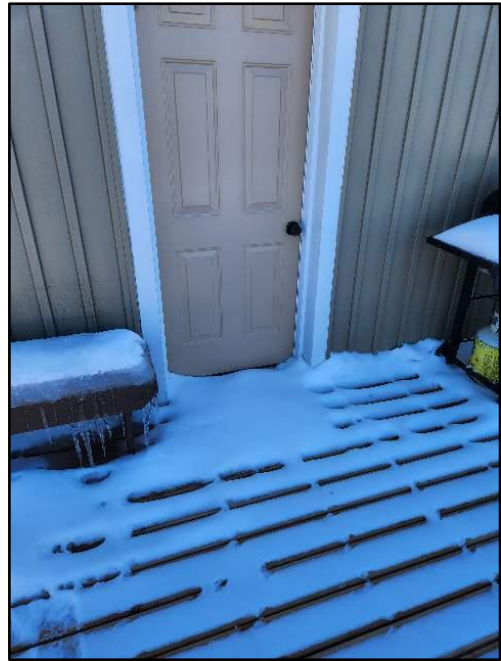
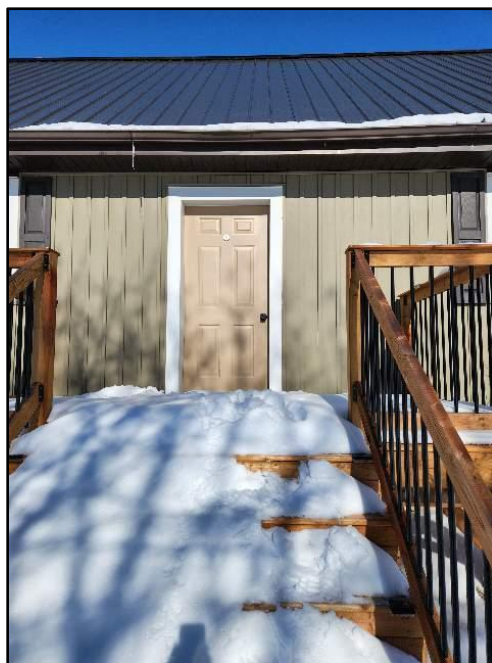
18. No step up into building

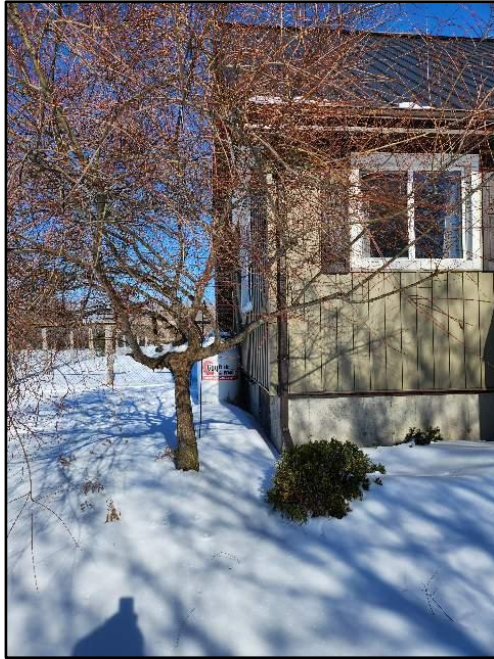
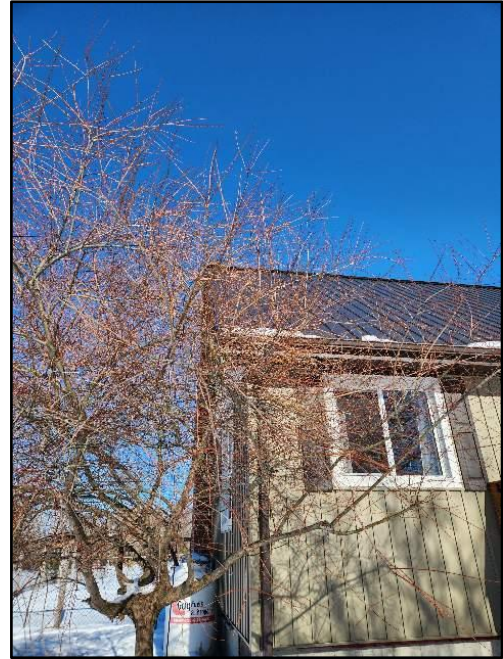
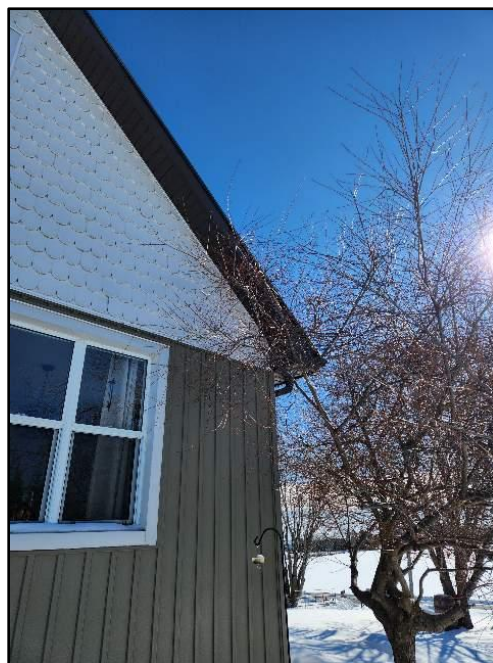
21. Trees or shrubs too close to building

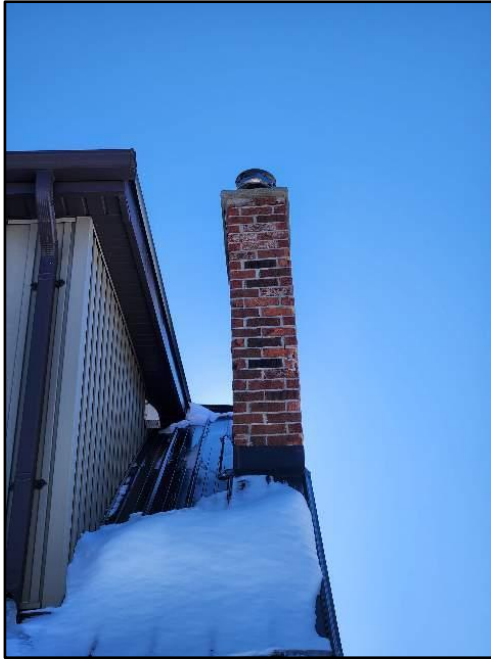
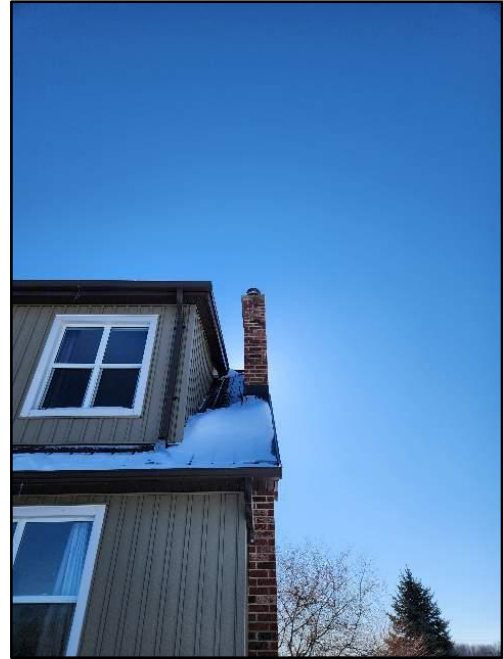
53. Settling or leaning

54. Settling or leaning

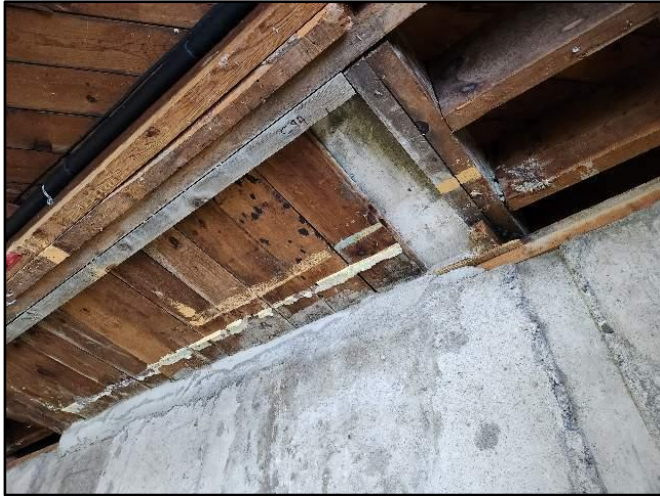
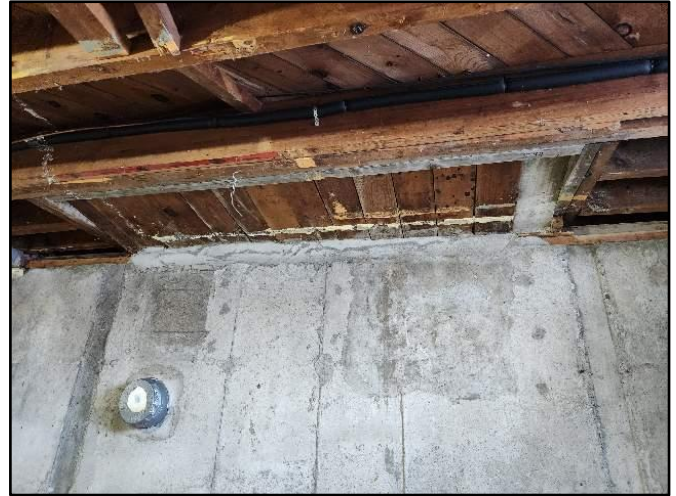
55. Wood forms not removed

56. Wood forms not removed

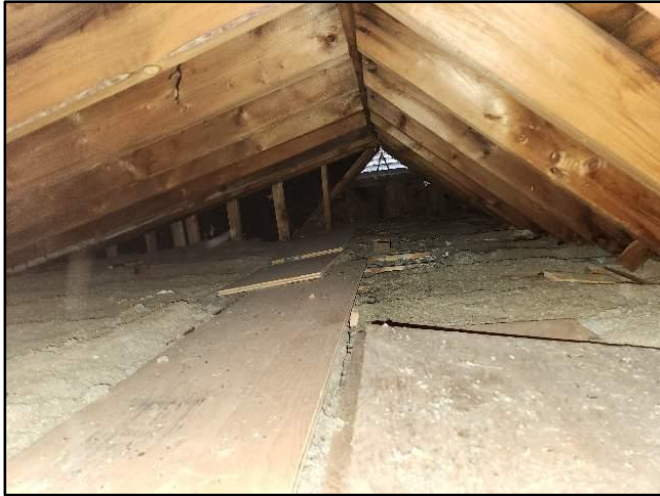
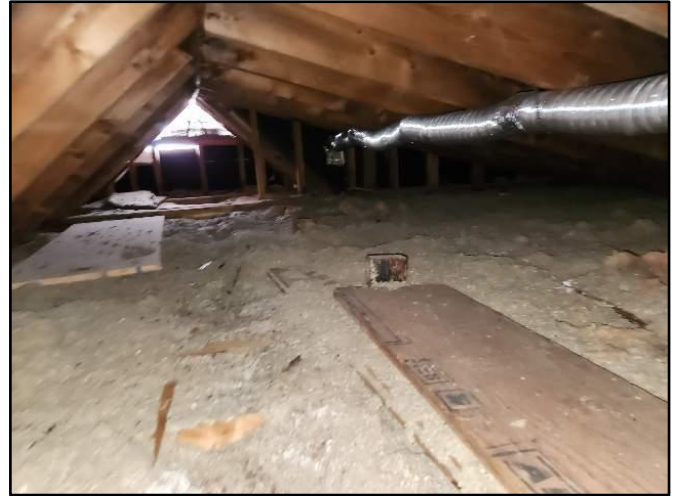
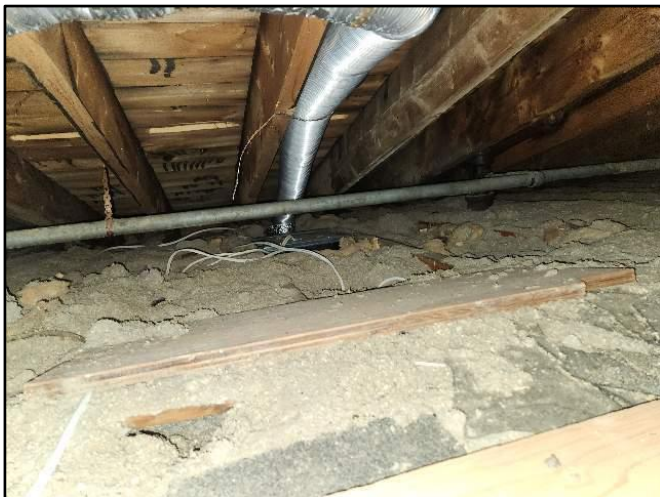
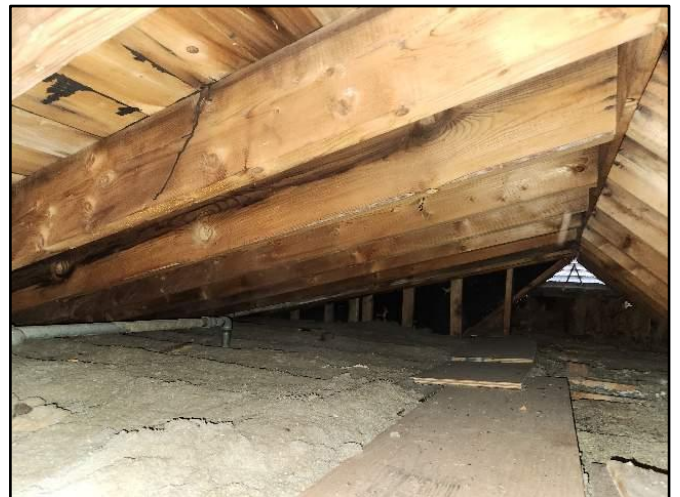
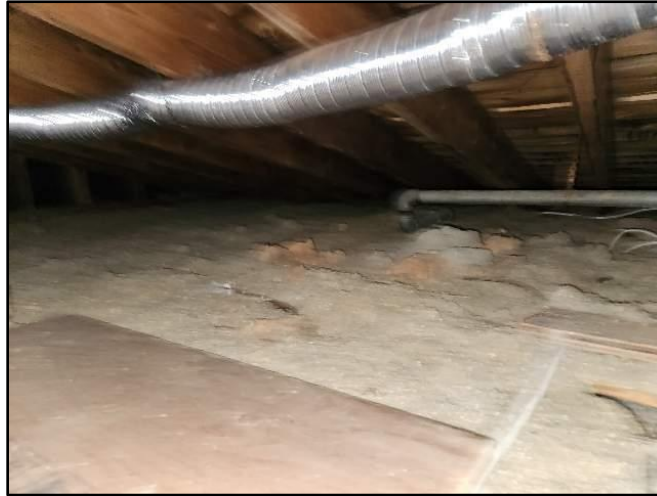
64. Amount less than current standards

65. Amount less than current standards

66. Amount less than current standards

67. Amount less than current standards

68. Amount less than current standards
