# Inspection Report

**Avelar Home Inspection Inc.**  
We see what you can't.

January 29, 2026

1234 Sample Road, Ottawa,  
Ontario, K1K 1K1

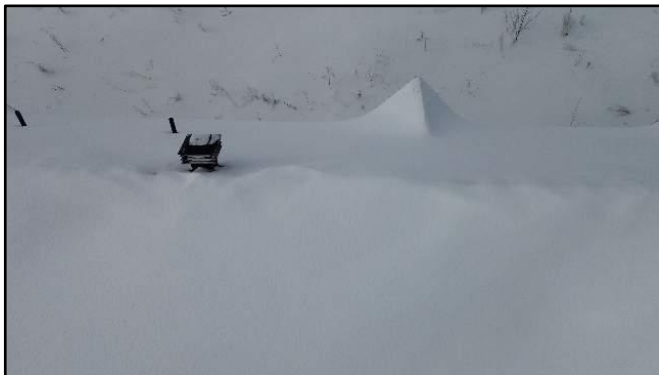
1. Snow/ice/frost

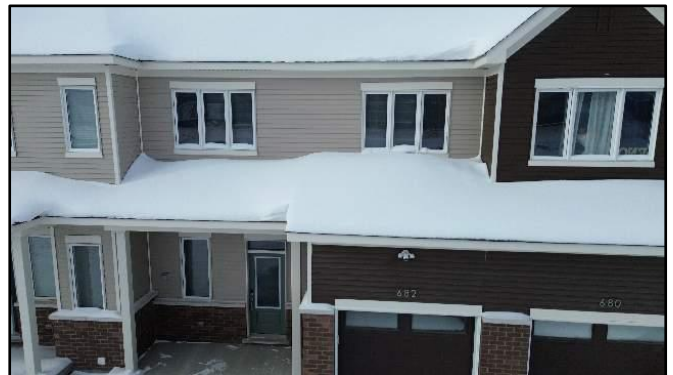
2. Snow/ice/frost

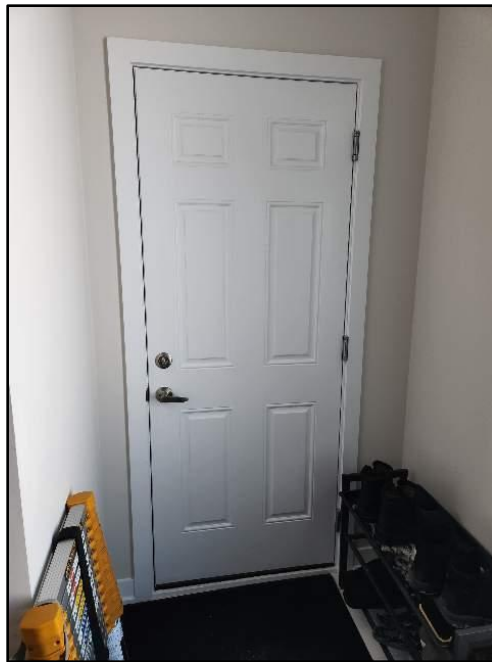
9. Does not close fully

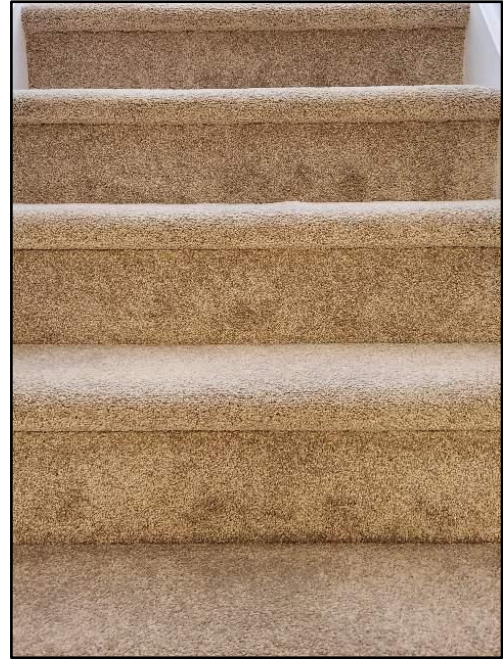
28. Buckled

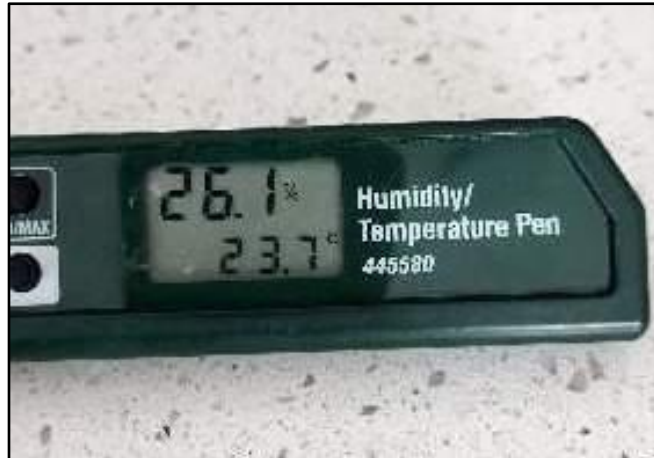
31. Excess condensation

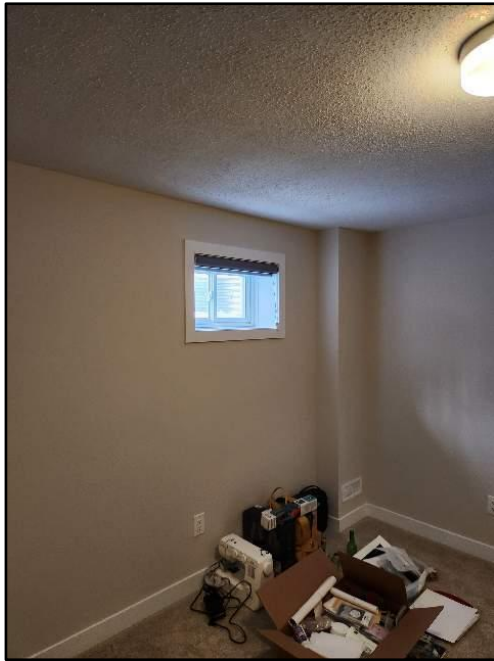
- Clear opening area smaller than 0.35 m<sup>2</sup>
- Opening height or width less than 380 mm
- Sashes or hardware obstructing full opening
- Inability to exit without special tools or knowledge

32. Too small

The inspector recommends evaluation and correction by a qualified contractor or code compliance specialist. Remediation may involve replacing or modifying window units to meet the egress standards outlined in the Ontario Building Code to ensure occupant safety and legal conformity.

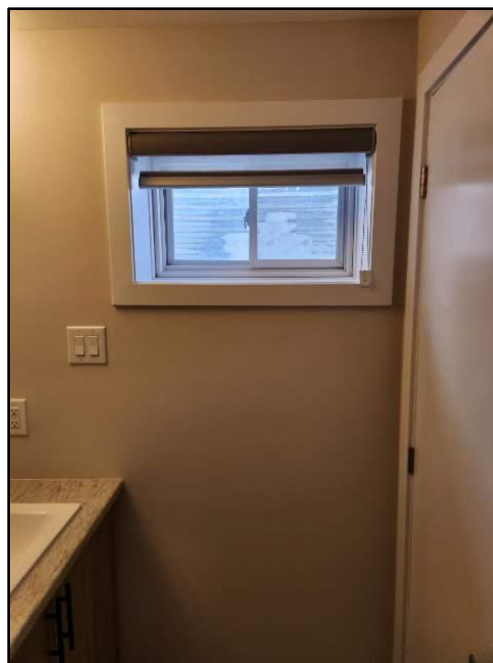
34. Too small

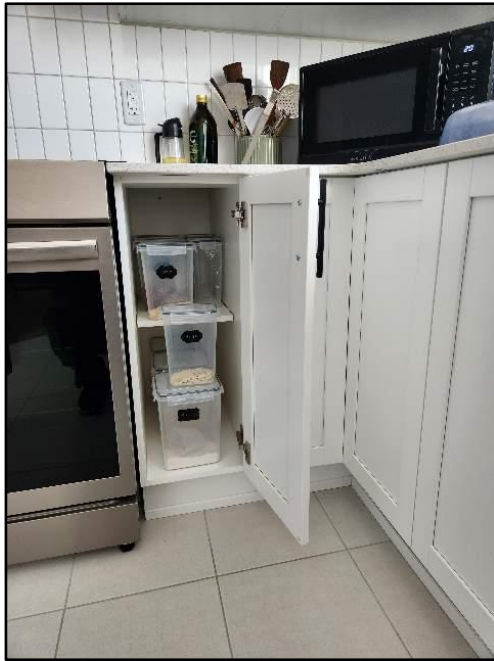
81. 11.3 Cabinet doors or drawer faces are w

**TASK:** Submit to Tarion for review

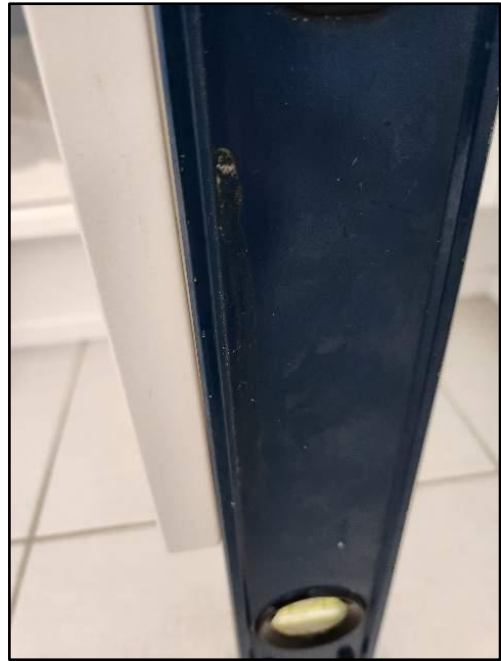
82. 11.3 Cabinet doors or drawer faces are w

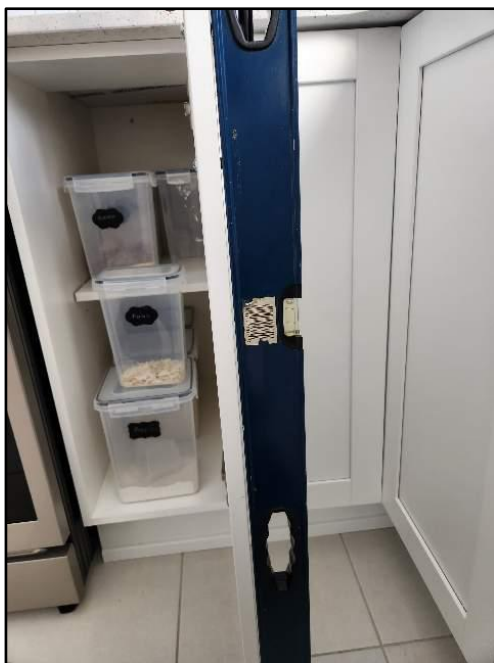
83. 11.3 Cabinet doors or drawer faces are w

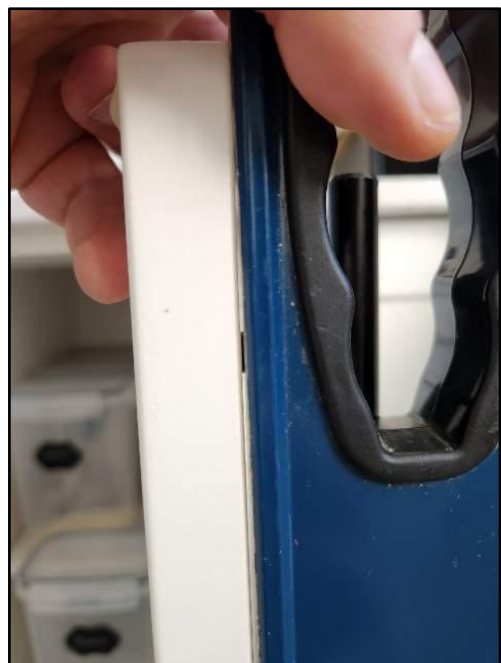
84. 11.3 Cabinet doors or drawer faces are w

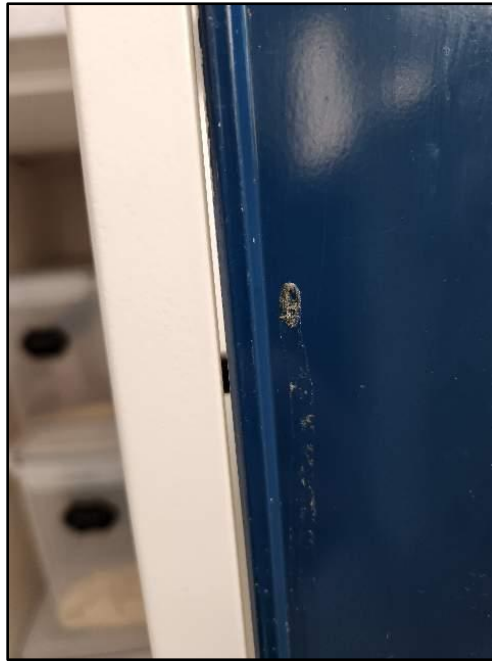
85. 11.3 Cabinet doors or drawer faces are w

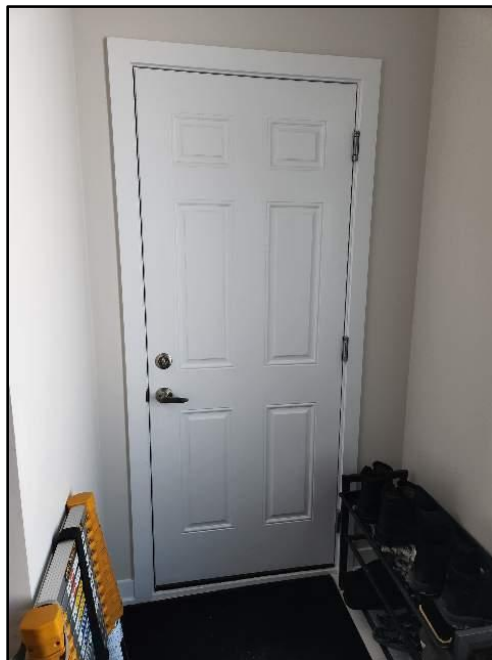
**LOCATION:** Foyer

92. Garage man-door auto-closer not function

**TASK:** Submit to Tarion for review
