# Inspection Report

**Avelar Home Inspection Inc.**  
We see what you can't.

Inspection Date:  
February 13, 2026

For the property at:  
123 Sample Road, Ottawa, Ontario

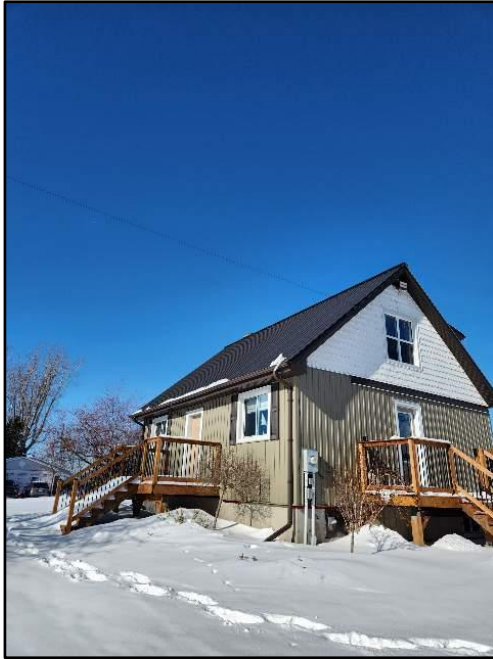
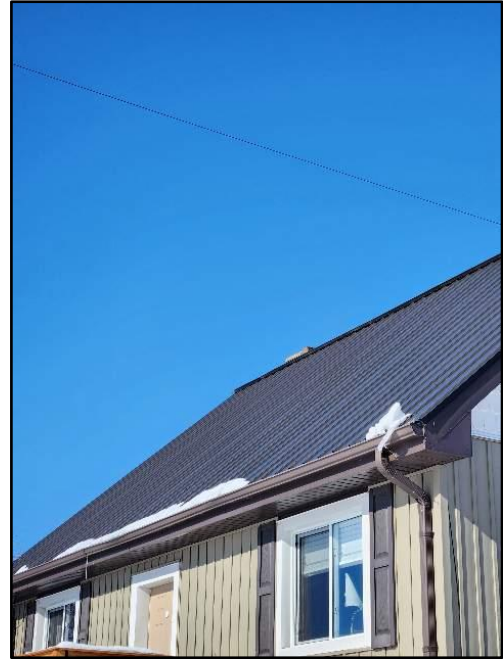
- **During the inspection, the inspector observed that they were missing safety devices on the metal roof . The inspector recommends upgrading and providing the snow cleats which would prevent snow from sliding off of the roof possibly damaging or injuring.**

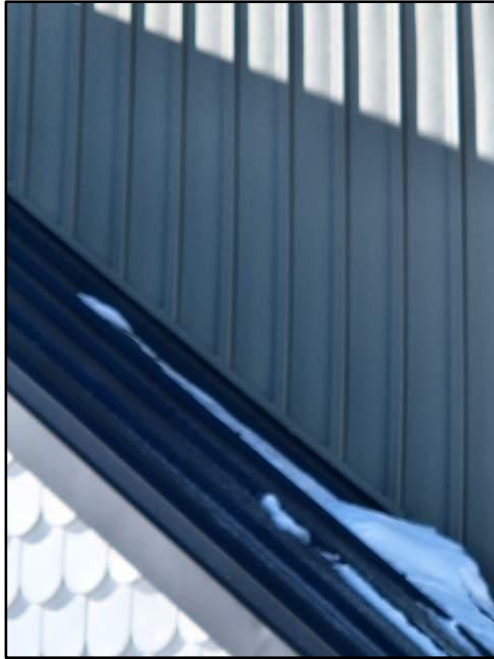
During the inspection, the inspector observed that siding was not adequately cut back from the roof surface at one or more roof/sidewall flashing locations.

Best practices recommend that siding be cut back a minimum of 1½ to 2 inches above the roof surface to allow for proper flashing installation and to prevent moisture wicking, rot, and sealant failure.

When siding contacts or overlaps the roof, it can trap water and debris, obstruct flashing, and accelerate deterioration of both the siding and roofing materials — especially in climates with freeze-thaw cycles, snow accumulation, or wind-driven rain.

4. Siding not cut back

The inspector recommends evaluation by a reputable roofing or exterior contractor to determine whether cutting back the siding and properly integrating flashing is warranted to restore long-term weather protection and prevent future damage.

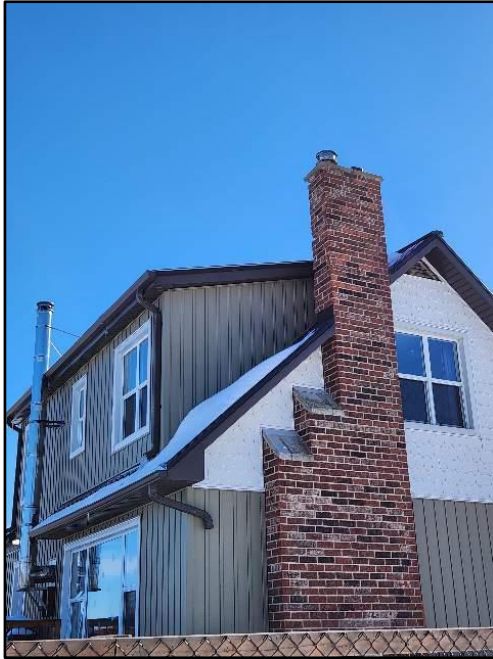
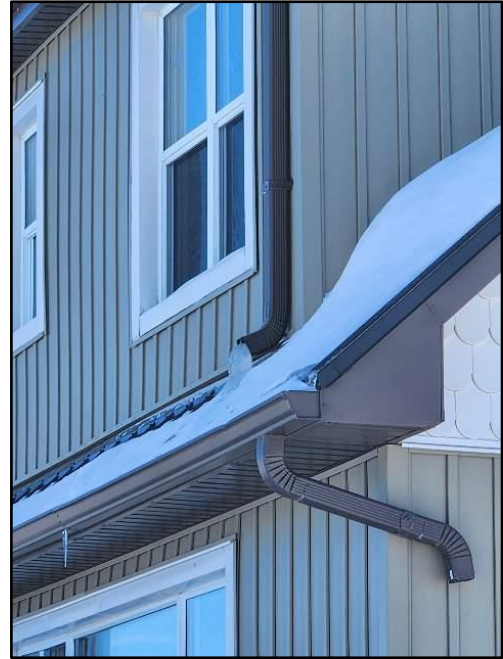
During the inspection, the inspector observed that one or more downspouts discharged directly onto a lower roof surface.

While this configuration is sometimes used in multi-level roof designs, it can lead to premature wear, granule loss, and moisture intrusion at the discharge point — especially in climates with freeze-thaw cycles, seasonal temperature swings, and acidic precipitation.

Concentrated runoff from upper gutters may overwhelm the lower roof's drainage capacity, causing splashback, shingle erosion, ice damming, and localized deterioration. In some cases, this condition may void manufacturer warranties, compromise fire resistance ratings, or accelerate roof aging.

12. Discharge onto roofs

The inspector recommends evaluation by a reputable contractor experienced in roof drainage systems to determine whether downspout extensions, diverters, or system redesign is warranted to improve water management and protect the roof surface.

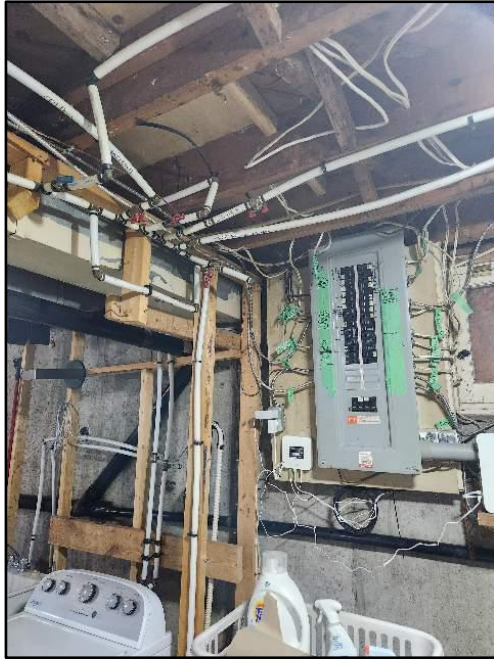
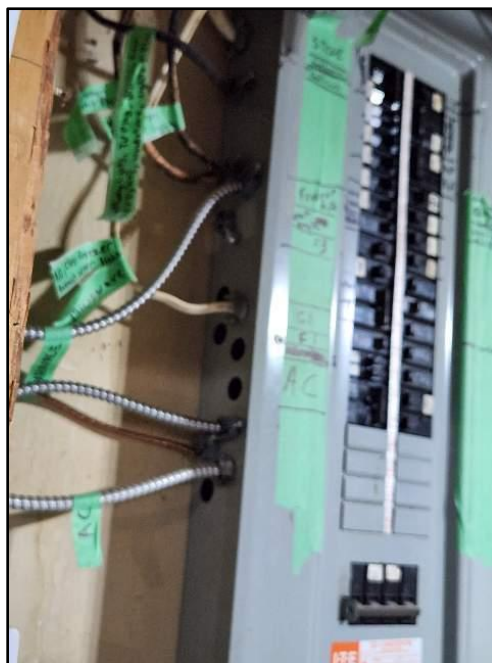
35. Openings in panel

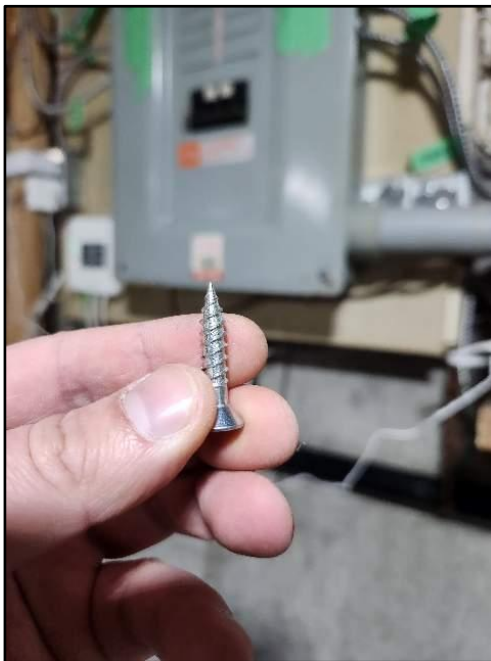
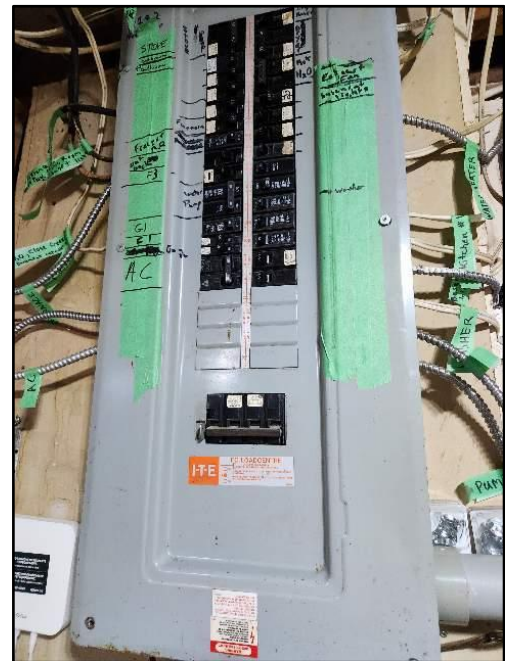
- **Incorrect Fasteners**

During the inspection, the inspector observed improper fasteners securing the panel cover or interior components, indicating potential mechanical hazard, code non-compliance, or electrical safety risk.

- Use of drywall screws, self-tapping screws, or wood screws on panel cover
- Sharp-tipped fasteners that may pierce wire insulation or energized components
- Loose or mismatched screws compromising dead front security
- Difficulty removing panel cover due to thread mismatch or stripped holes
- Safety hazard from arcing, energized exposure, or inspection limitations

40. Incorrect Fasteners

41. Incorrect Fasteners

The inspector recommends evaluation by a qualified electrical contractor to determine whether fastener replacement, panel cover correction, or internal inspection for wire damage is warranted to restore proper safety and long-term performance.

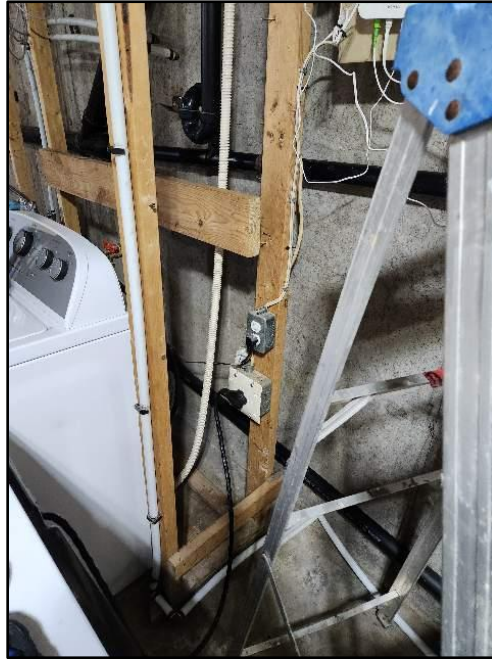
43. Laundry area

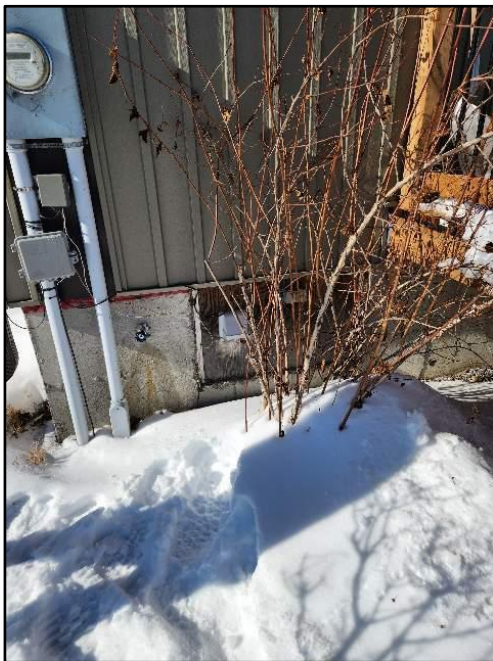
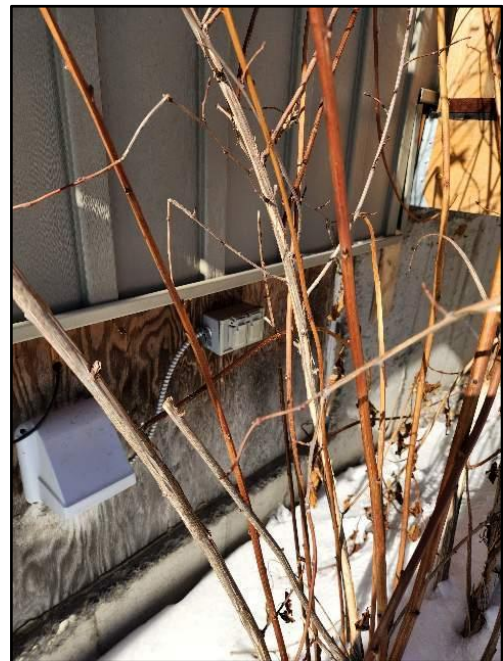
- **Outdoors**

44. Outdoors

45. Outdoors

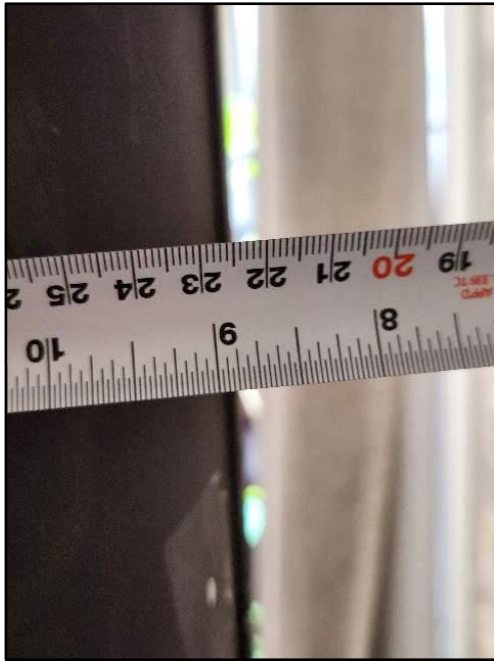
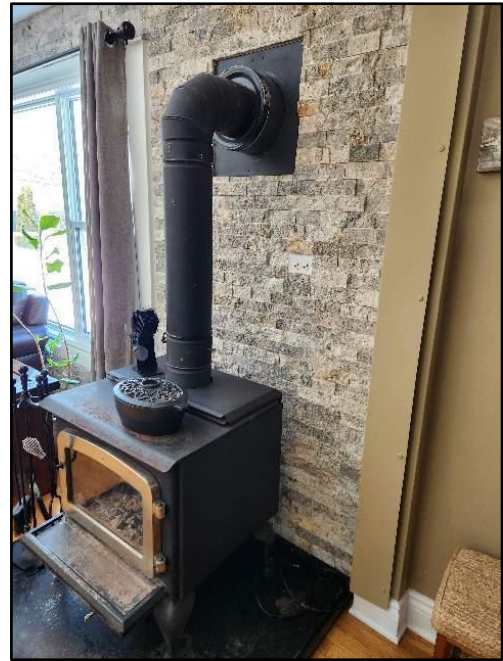
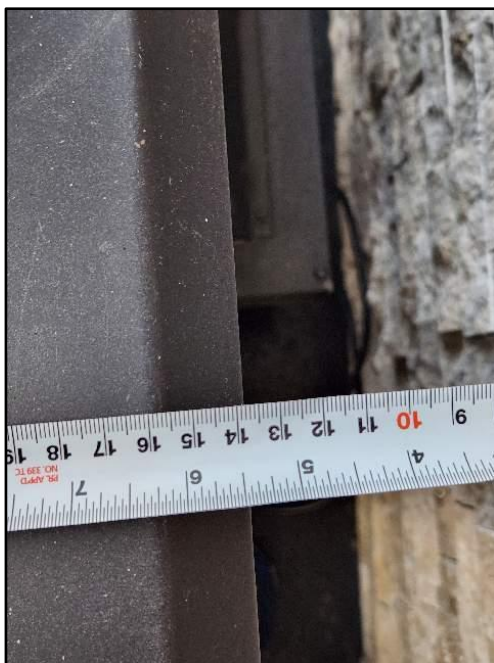
57. Side or back wall - combustible clearanc

58. Side or back wall - combustible clearanc

59. Side or back wall - combustible clearanc

60. Side or back wall - combustible clearanc

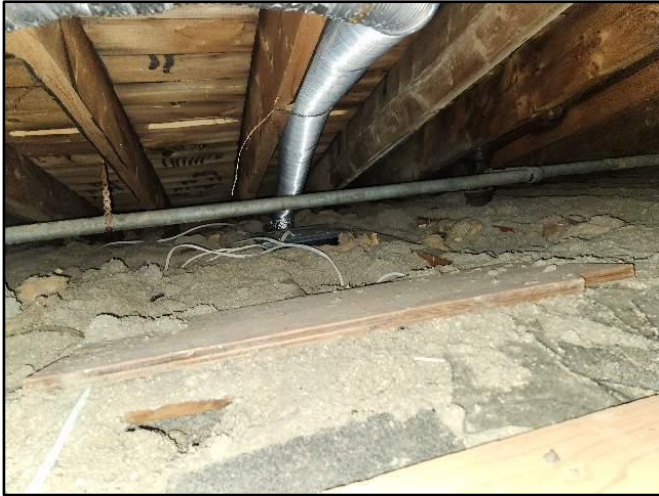
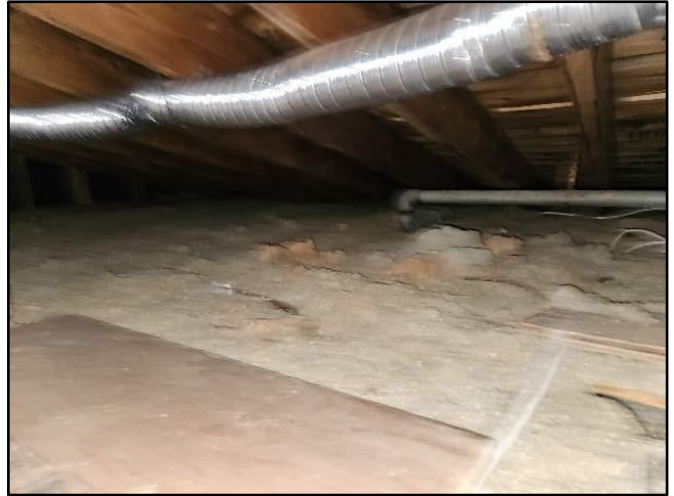
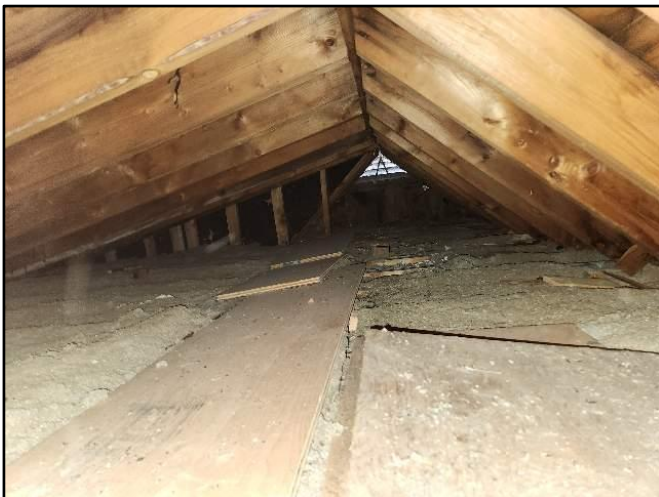
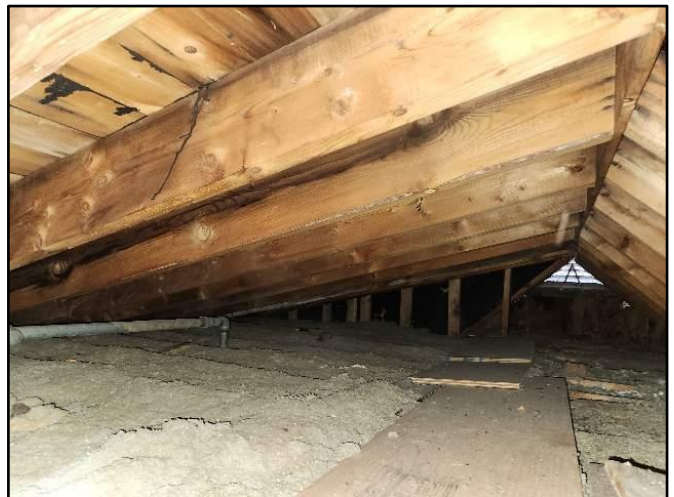
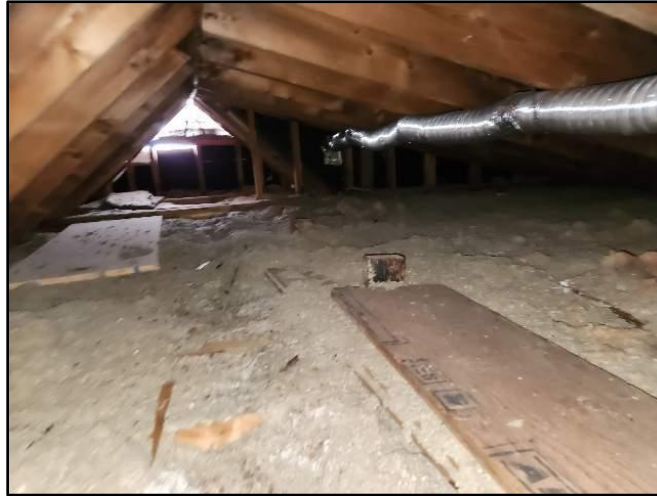
- **Compressed**

69. Compressed

70. Compressed

71. Compressed

72. Compressed

73. Compressed

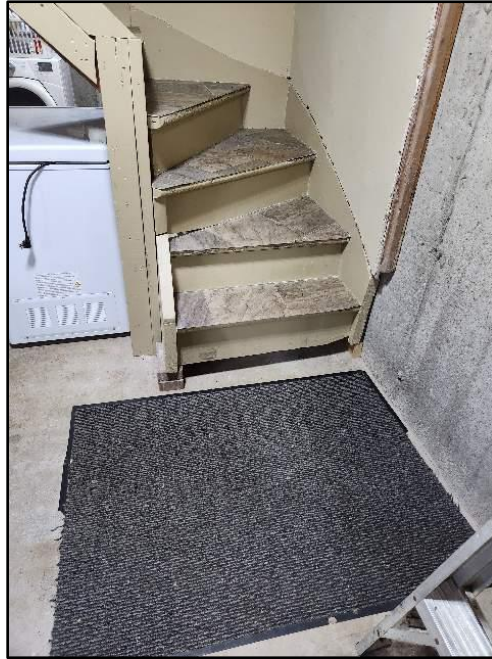
92. Rise or run not uniform

Observed conditions may include:

- Poor design or layout during original construction
- Settling or shifting of structural components
- Improper repairs or retrofits
- Use of non-standard materials or prefabricated elements

**IMPLICATIONS:** Trip or fall hazard

recommends evaluation and correction by a qualified contractor or stair specialist to ensure safe and code-compliant stair geometry.

**TASK:** Repair or replace Further evaluation
